Update "With-Site-Visit" Reserve Study

Sunland Division 17 Owners' Association Sequim, WA

Report #: 19544-6
For Period Beginning: January 1, 2018
Expires: December 31, 2018

Date Prepared: June 30, 2017

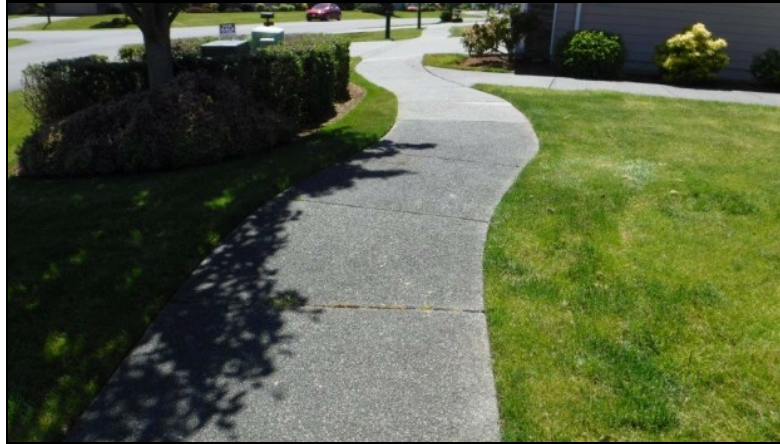
Comp #: 100 Concrete - Repair/Replace

History: Periodic repairs

Useful Life:
5 years

Remaining Life:
2 years
