## **“Full” Reserve Study**

## **Sunland Division 17 Owners Association Sequim, WA**

**Report #: 19544-3**  
**For Period Beginning: January 1, 2015**  
**Expires: December 31, 2015**

**Date Prepared: June 19, 2014**

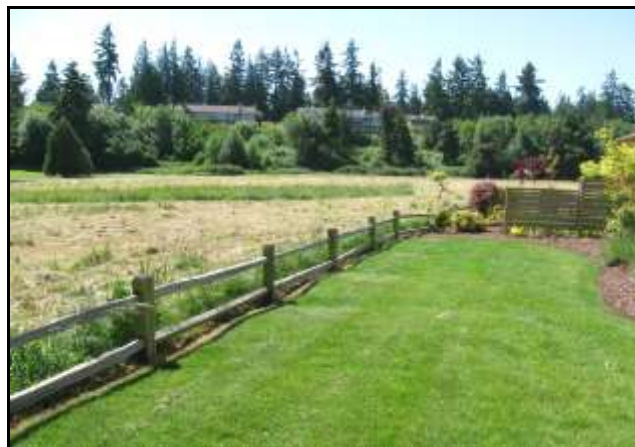
Useful Life:  
25 years

Remaining Life:  
8 years

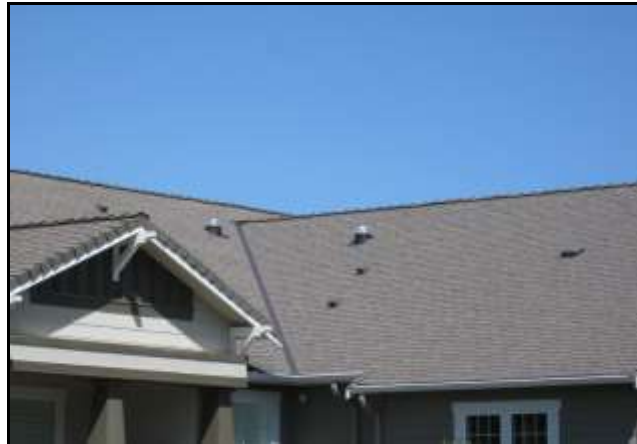
Useful Life:  
25 years

Remaining Life:  
18 years

Lower allowance, including skylight and solar tube replacement

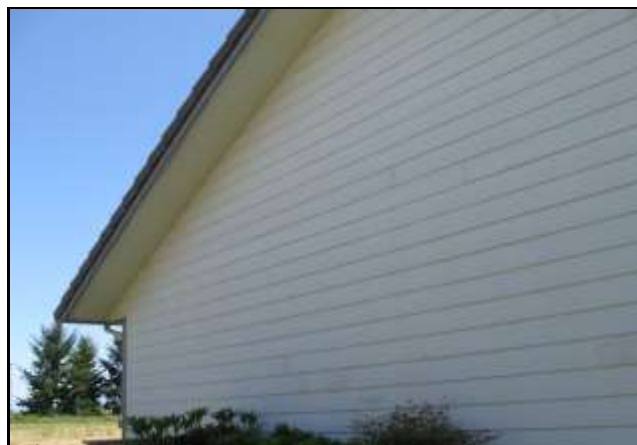
Remaining Life:

38 years

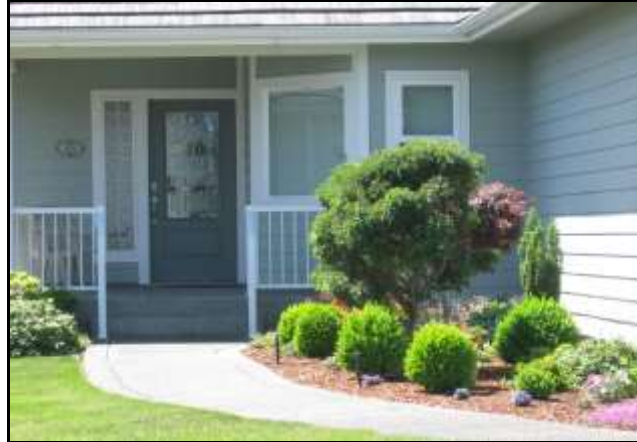
Useful Life:  
14 years

Remaining Life:  
0 years
