Sunland North HOA
Contact: Shirley Legg
320 Blakely Blvd | Sequim, WA 98382
206-550-5604 | vicepresident@sunlandnorth.org
Clallam County Parcels: 033008760006 and 033008760002

Sunland North Homeowner's Association (Sunland North HOA) owns the trees on Clallam County Parcel numbers 033008760006 and 033008760002 in Sequim. Sunland North HOA asked Peninsula Environmental Group to perform a tree risk assessment on trees bordering property target zones and to prepare a map and a report with detailed findings.

320 Blakely Blvd | Sequim, WA 98382

Tree Risk Assessment

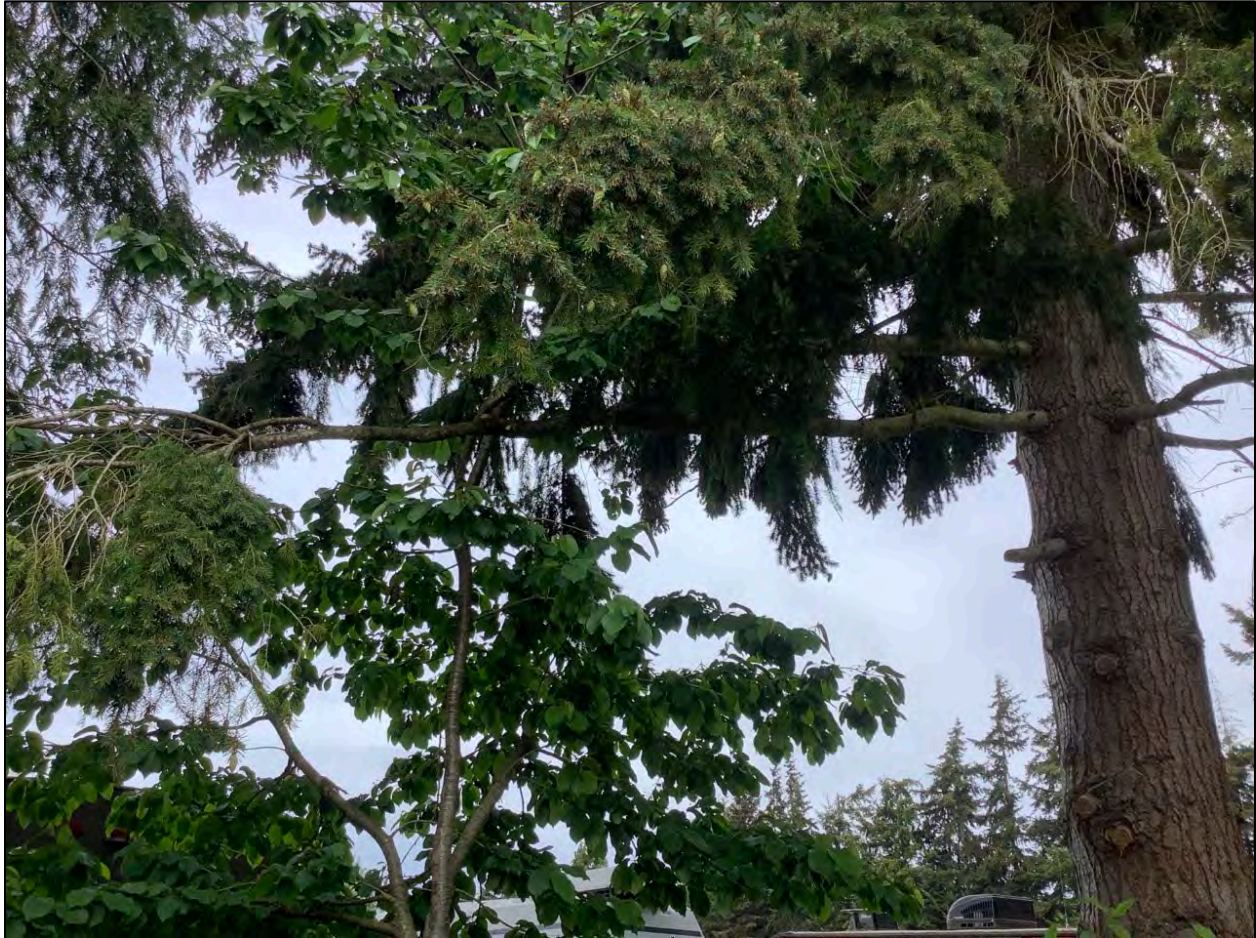
Photo 1: Prune Douglas-fir (Tree 14) branches away from cherry tree (Tree 13).

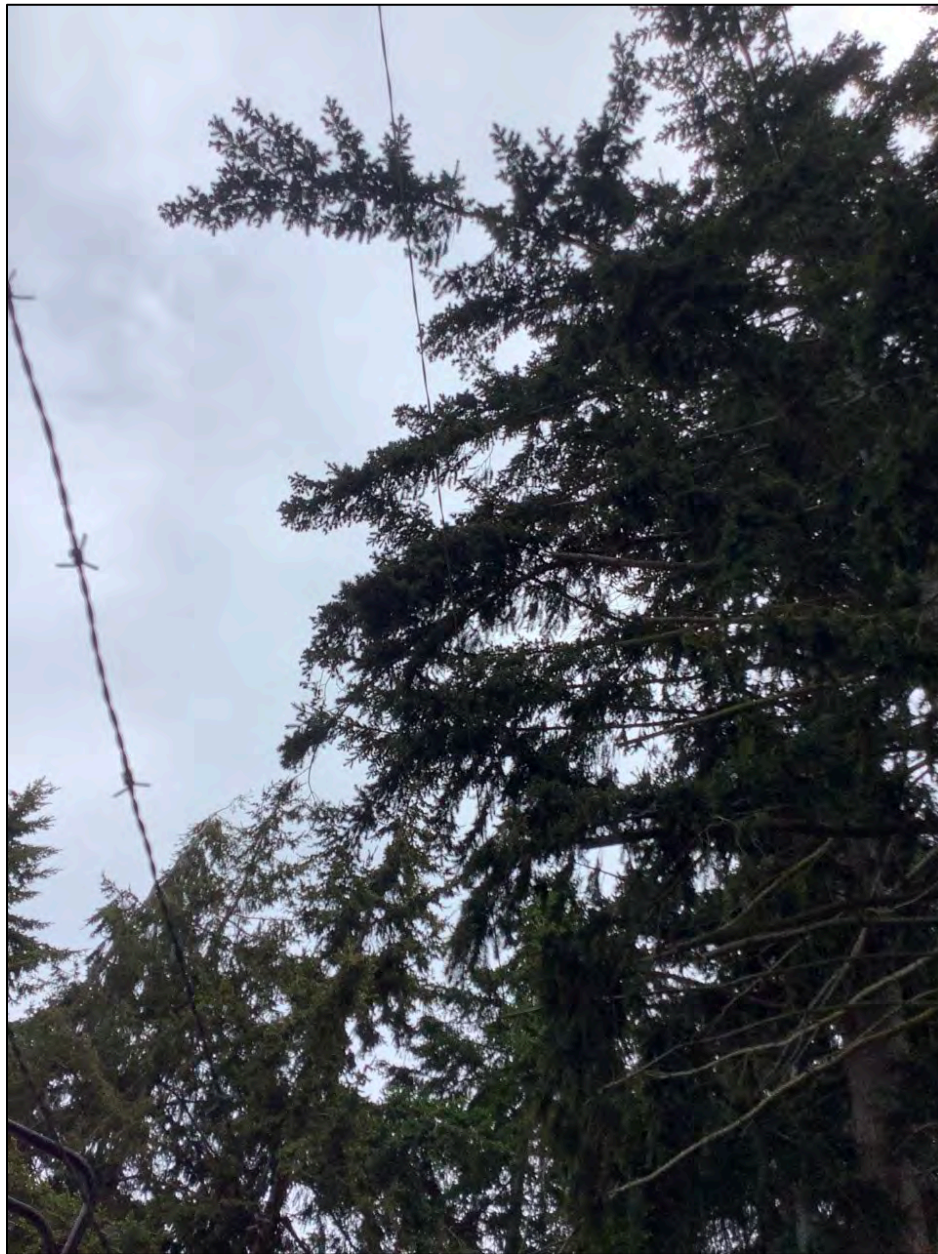
Photo 2: Prune Douglas-fir (Tree 24) for end-weight reduction.

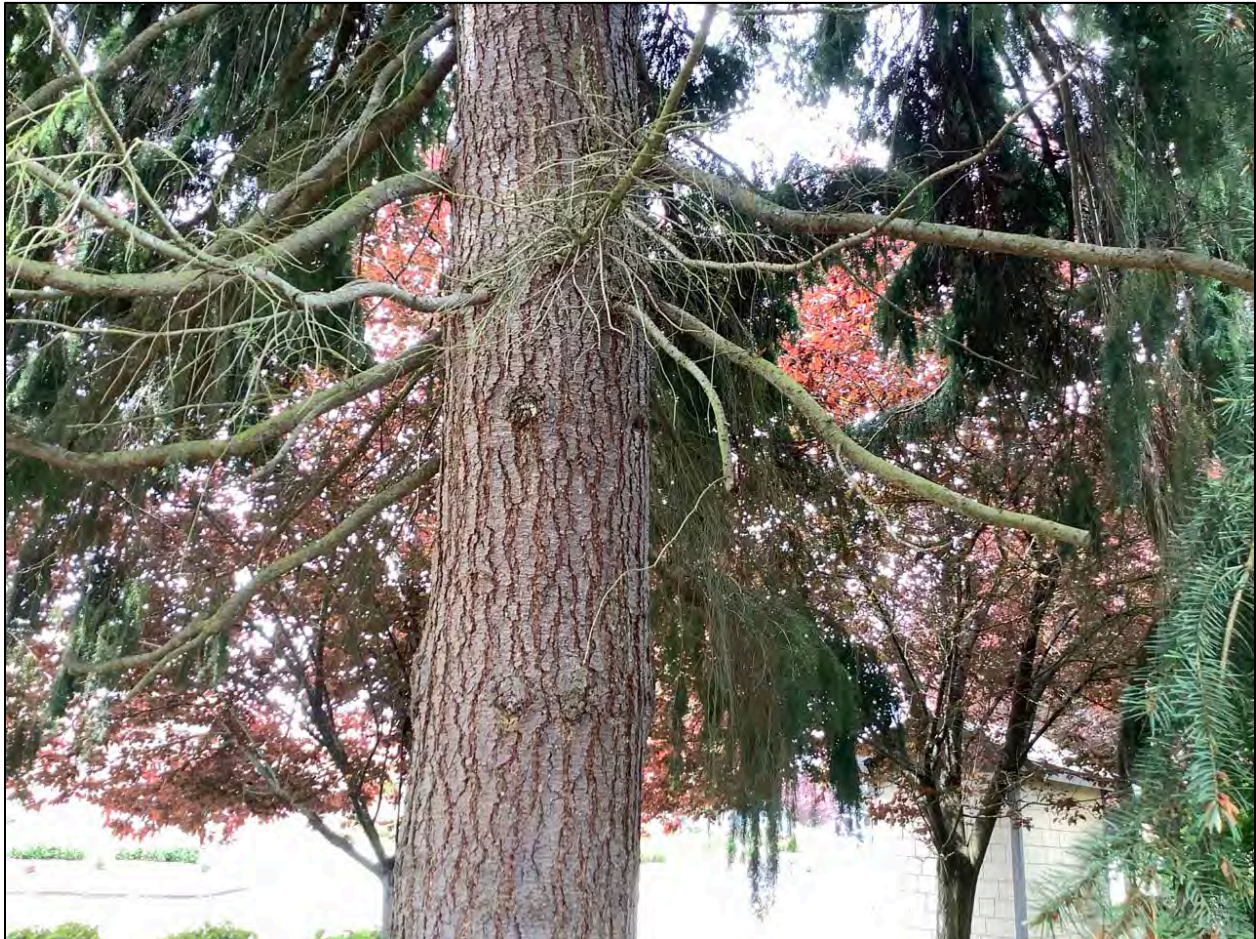
Photo 3: Tree 1 with dead wood to remove.

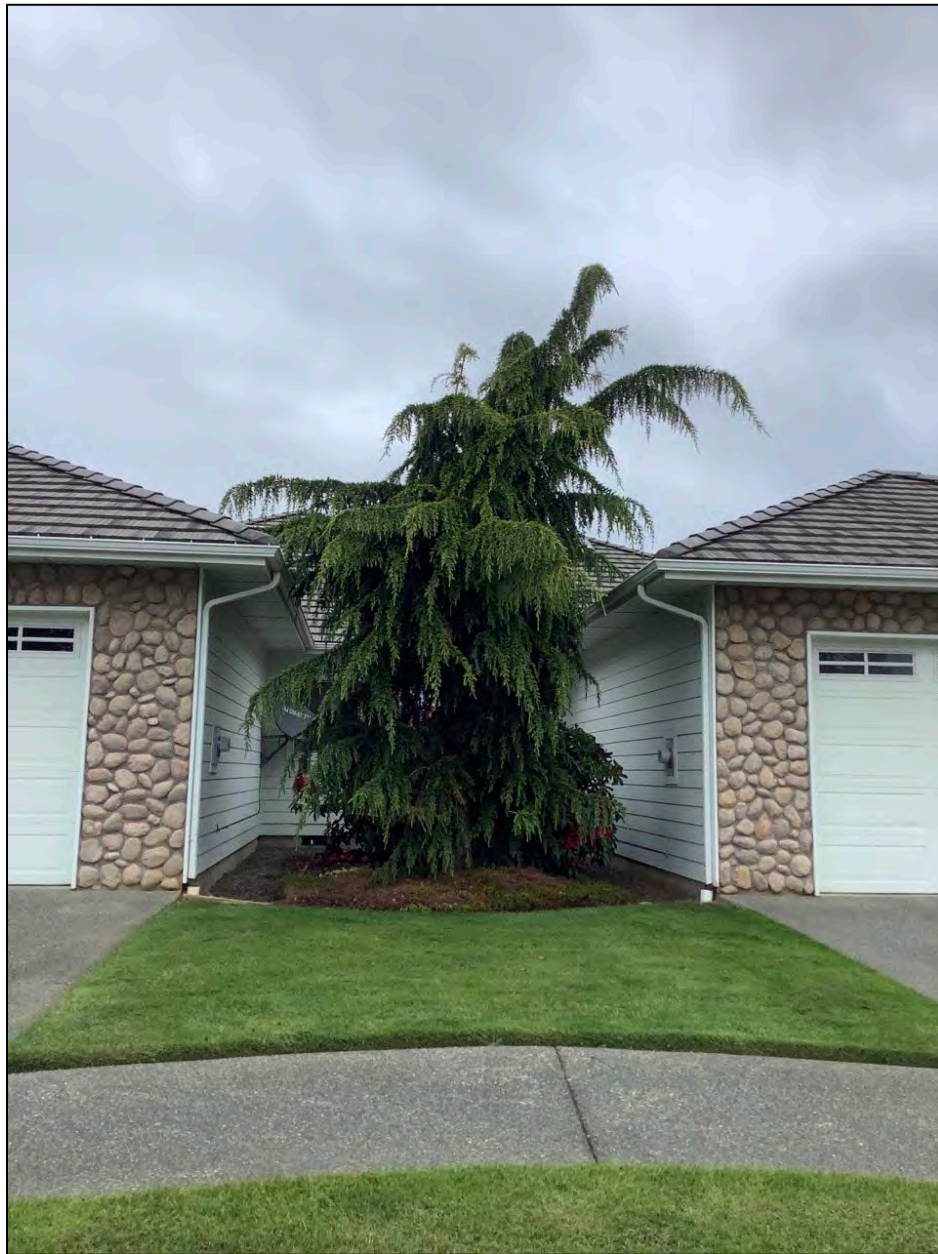
Photo 4: Prune away from roof and structures (Tree 43).

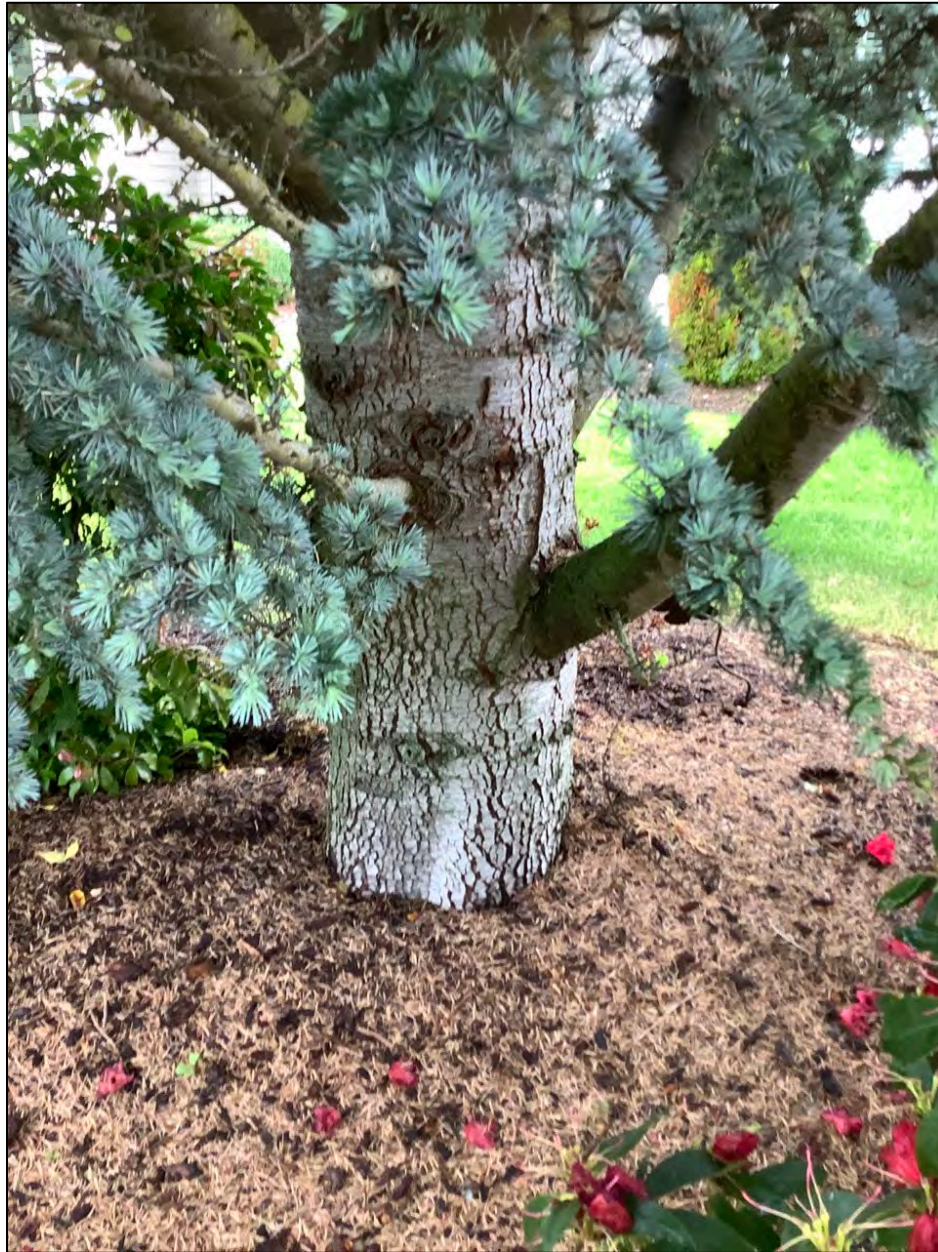
Over buried trunk- an over buried trunk, or root collar burial predisposes trees to a variety of health problems. Root collars with damaged bark are more susceptible to infection and disease. (See *Photo 5*)

Photo 5: Unbury trunk (Tree 36).

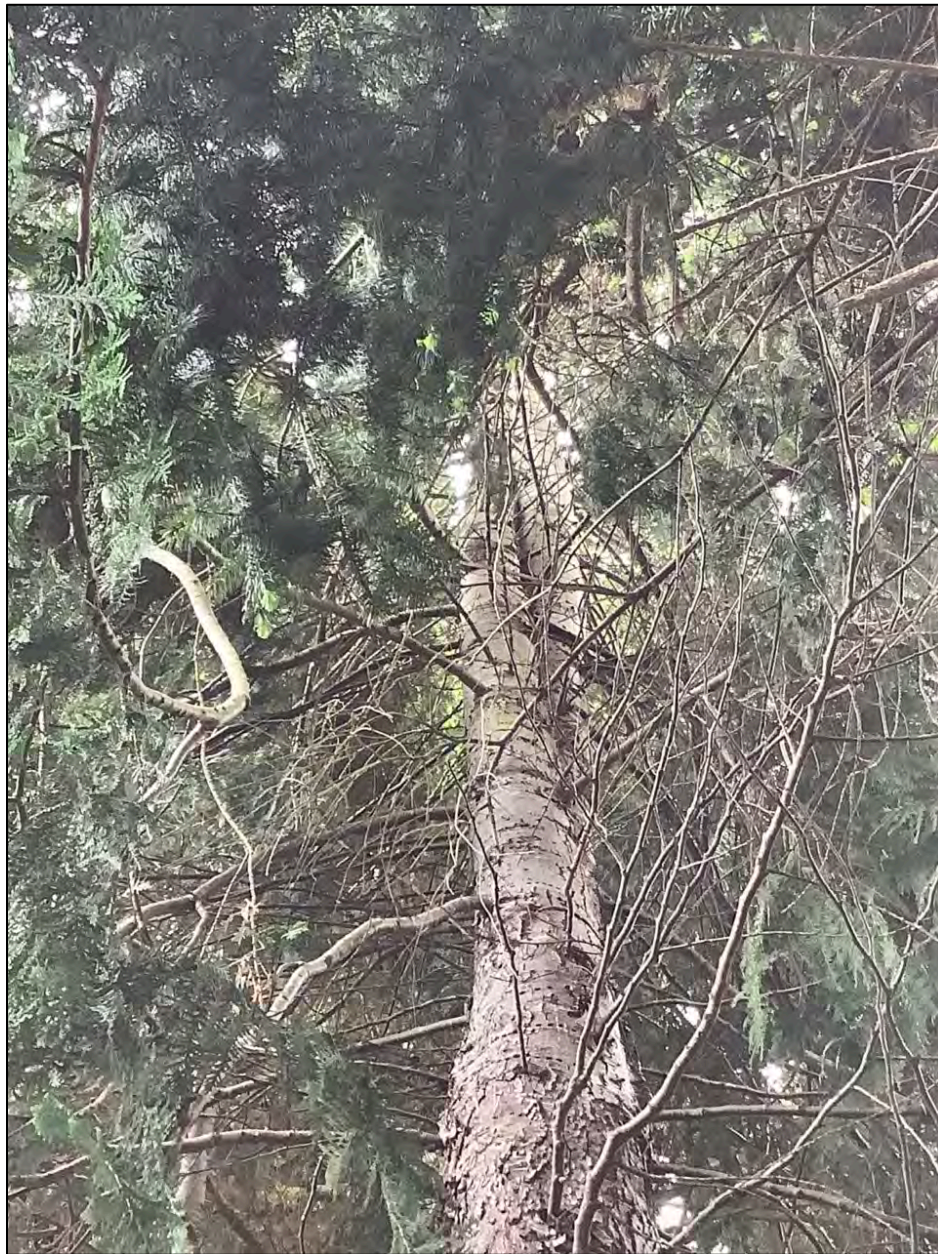
Photo 6: Consider removal due to health or risk (Tree 4).

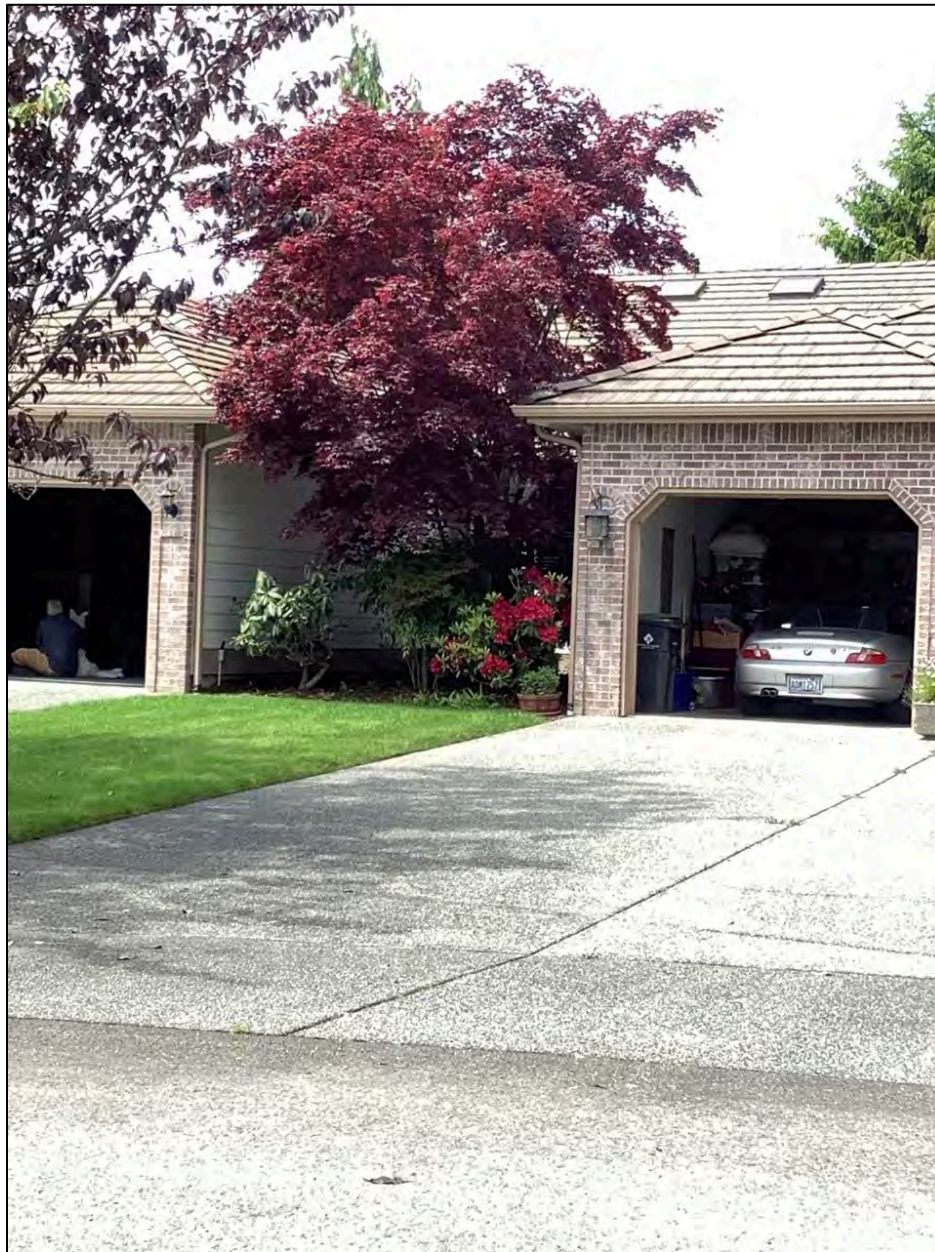
Photo 7: Consider removal and replacing with more suitable tree (Tree 55).

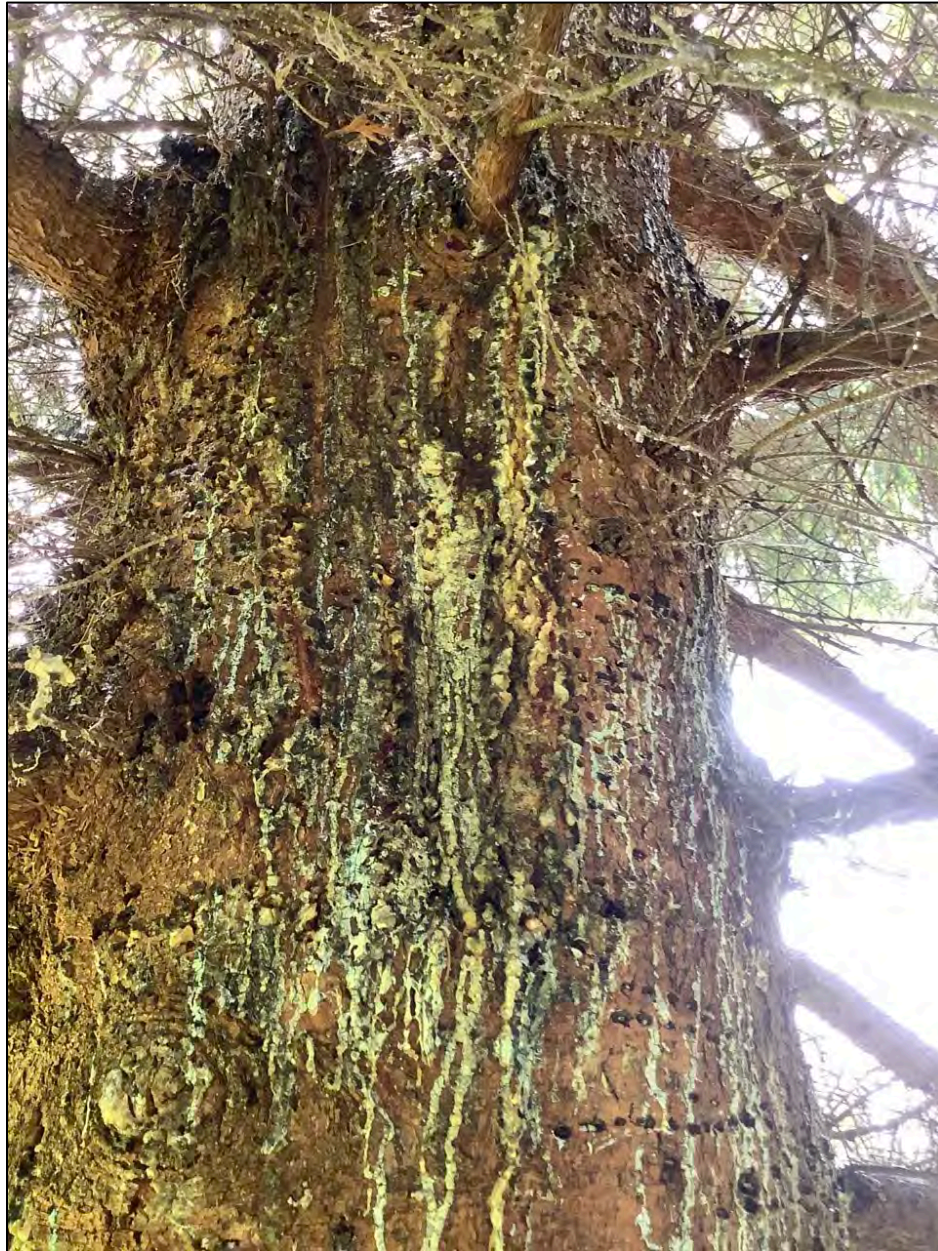
Photo 8: This tree (Tree 58) has an excessive amount of sap running down the trunk. Continue to monitor for signs of stress.

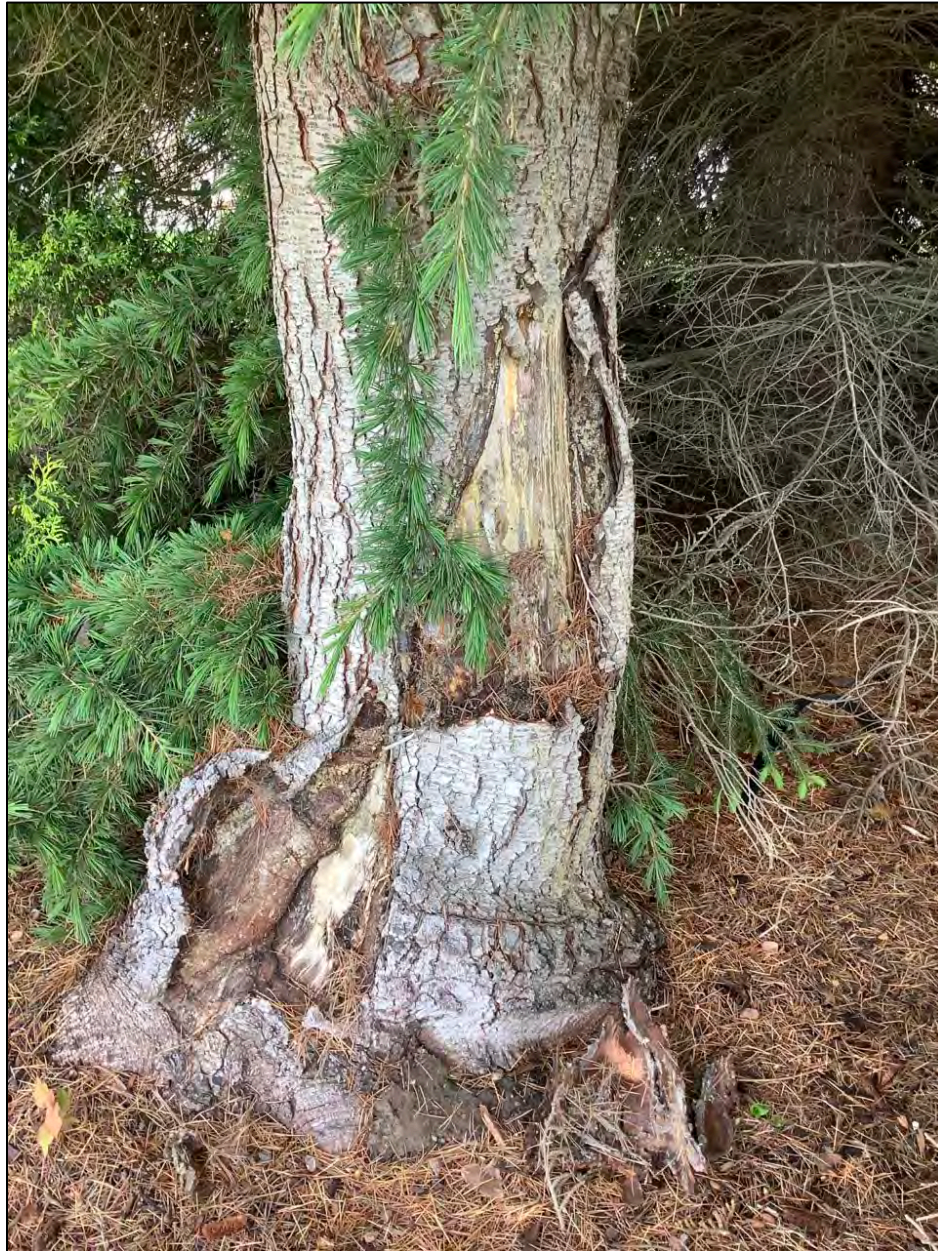
*Photo 9: Perform a more in-depth risk assessment with micro-resistance drill (also consider removing).
Tree 56.*

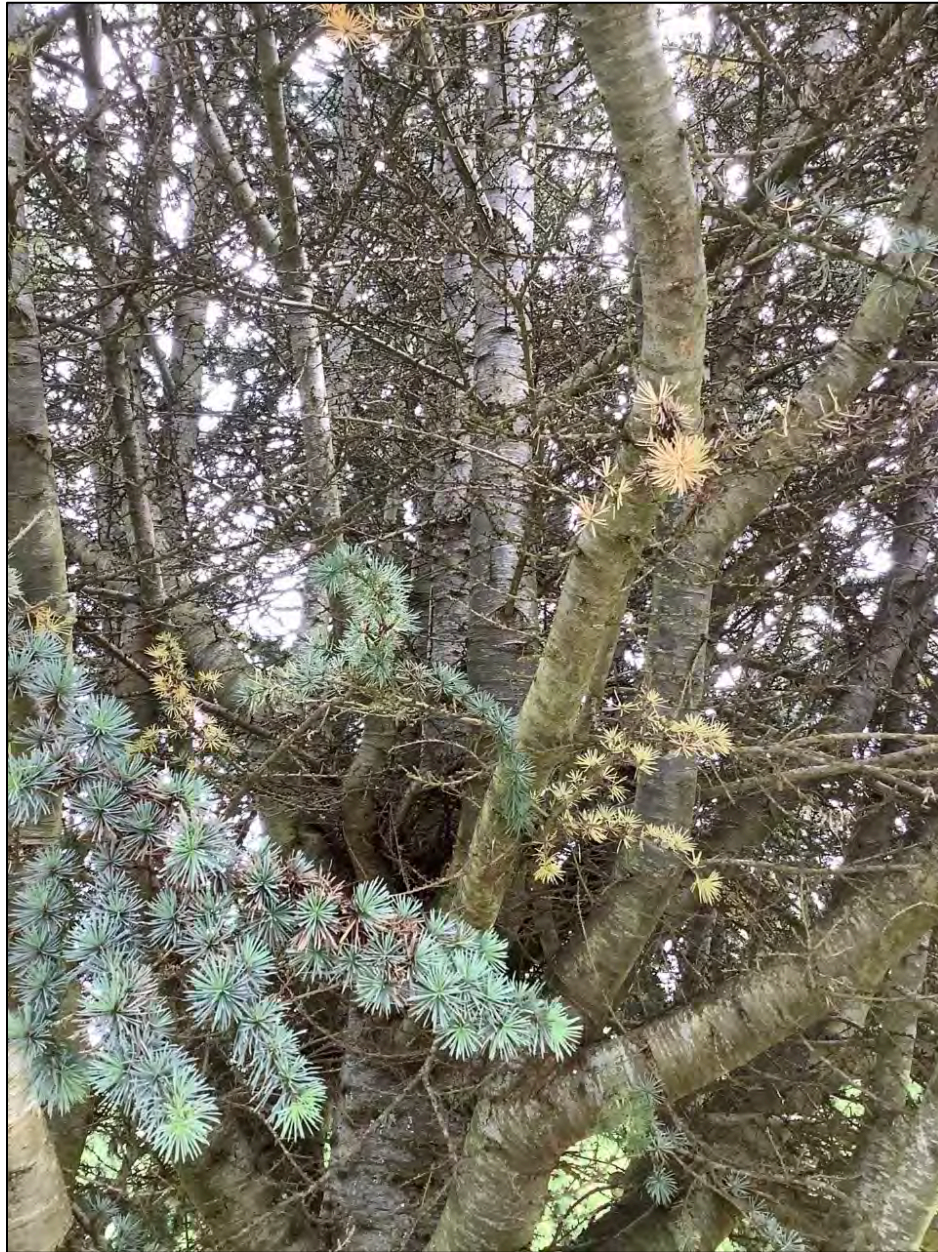
Photo 10: Reduce competing leaders (Tree 97).

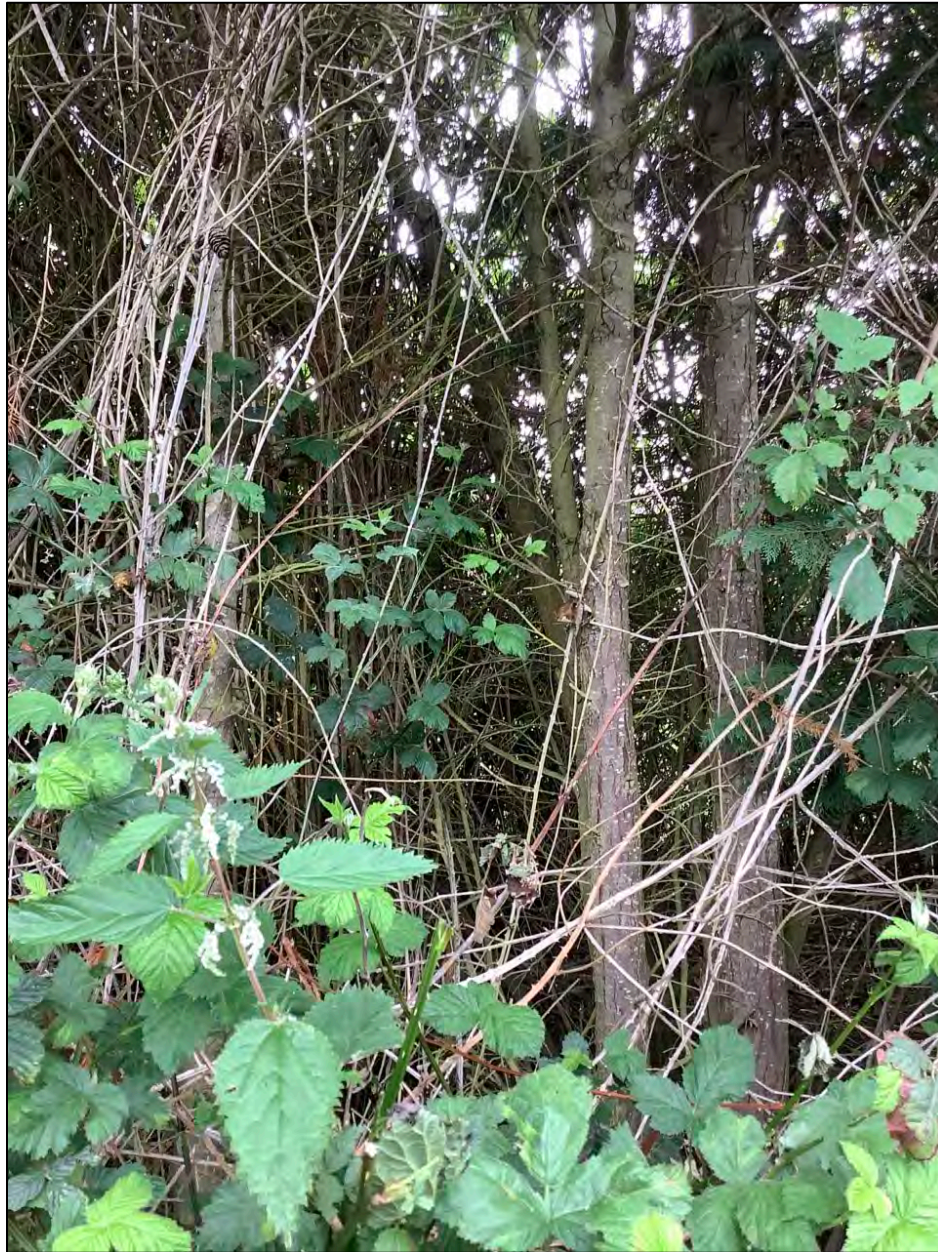
Photo 11: Control noxious weeds around tree (Tree 16).

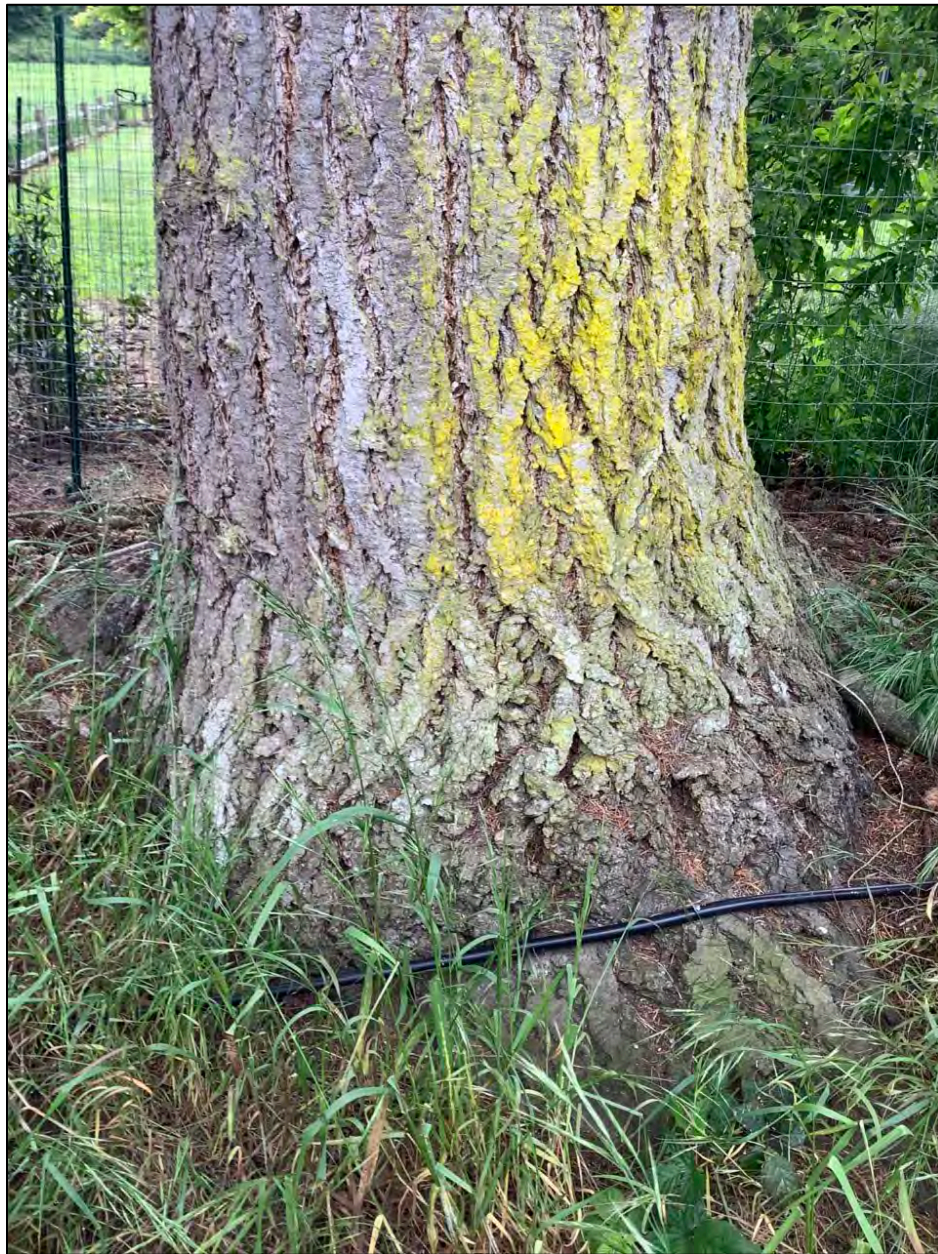
Photo 12: Tree 14 with girdling irrigation around trunk.

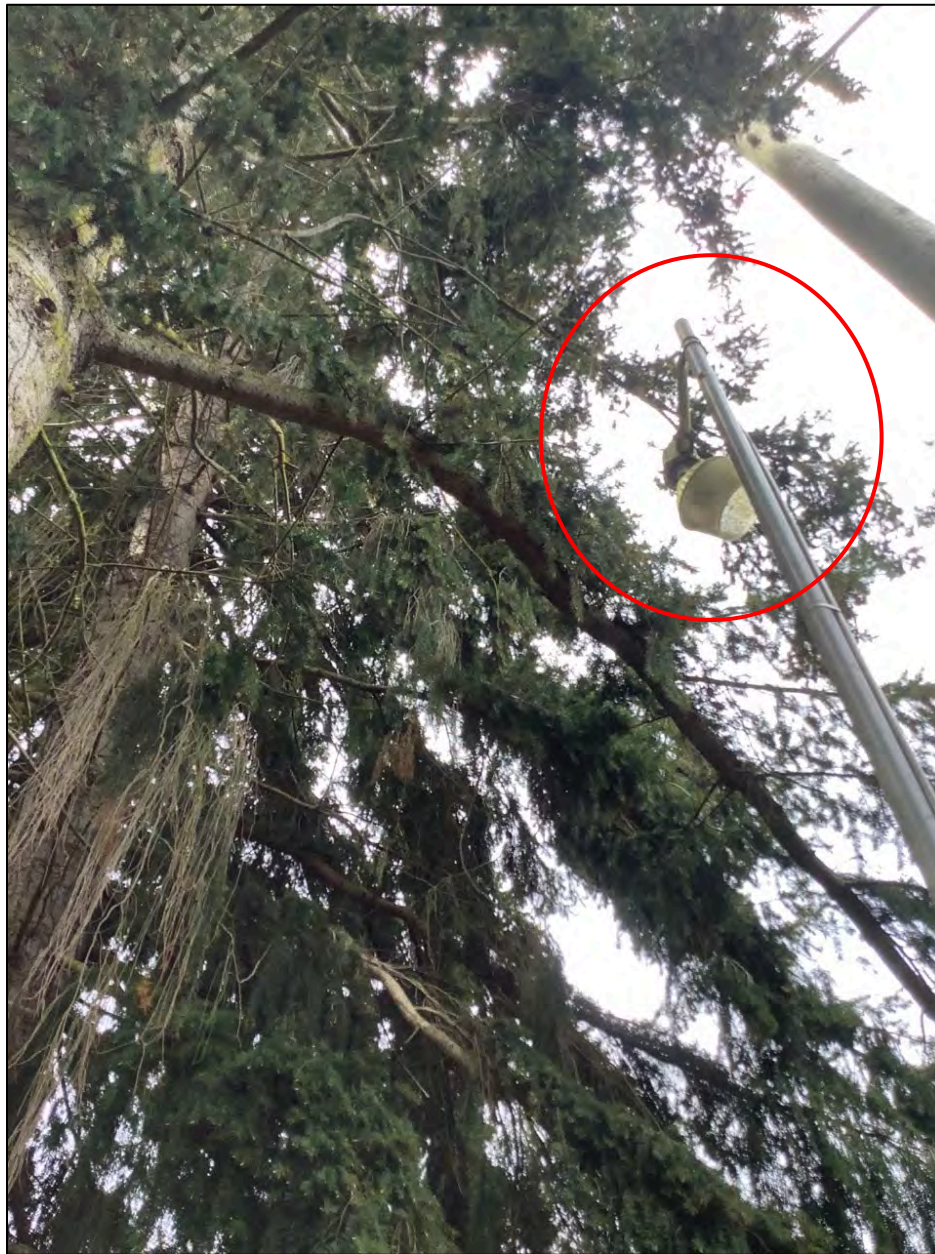
Photo 13: Note broken streetlight near Tree 2 (circled in red).

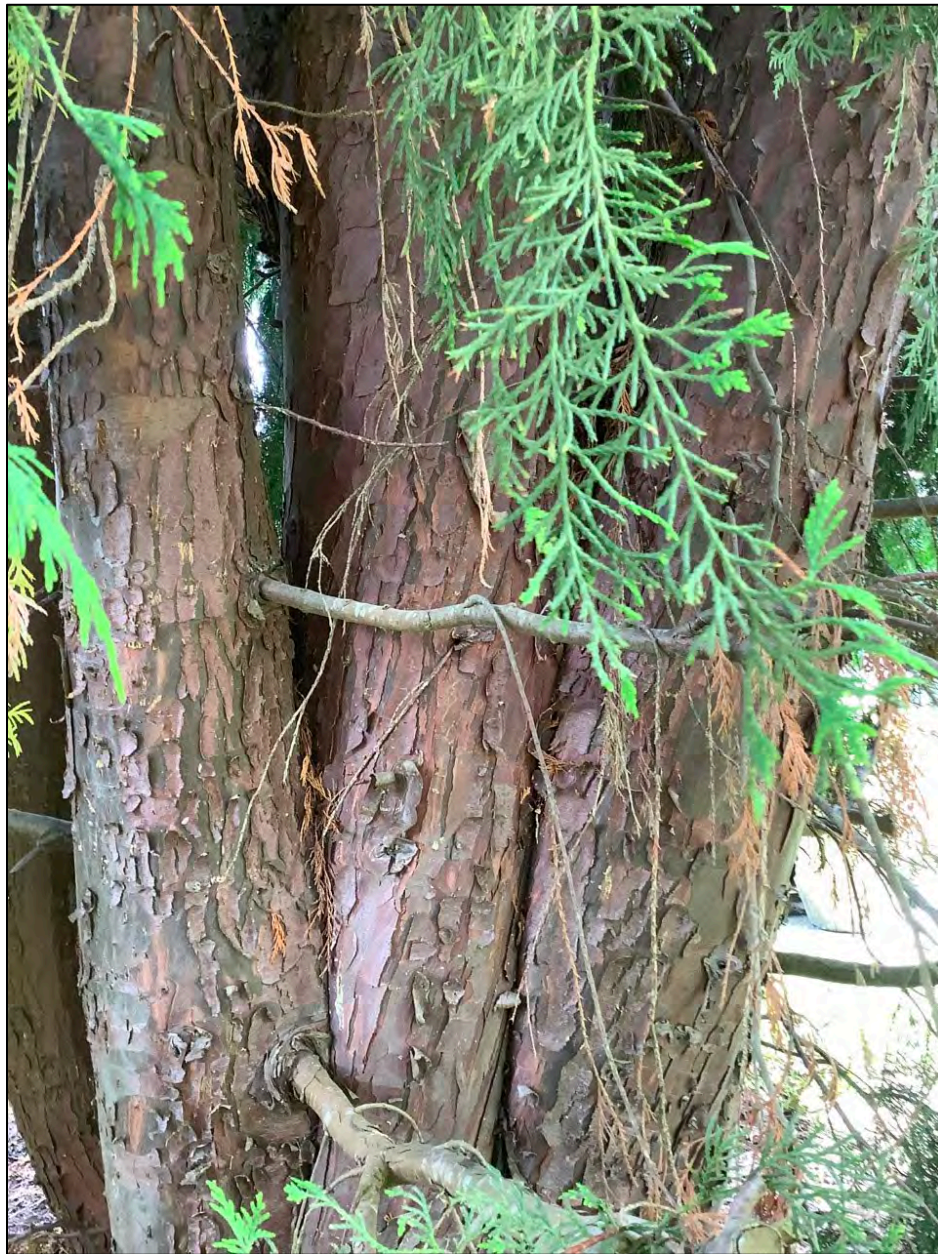
57	Weeping Nootka cypress	<i>Chamaecyparis nootkatensis</i> 'Pendula'	Moderate	Three trunks with included bark at base. One of them splits into two more trunks close together. The way they are most likely to fail will be into the grass, but the tree is located close to two houses. Consider cabling or remove and replace with smaller tree.
58	Norway spruce	<i>Picea abies</i>	Low	Appears healthy and low-risk but there is large amounts of sap running down the trunk. There is sapsucker (<i>Sphyrapicus</i> sp.) presence and damage, which is usually relatively benign. Continue to monitor tree.

Photo 14: Consider cabling (Tree 57).

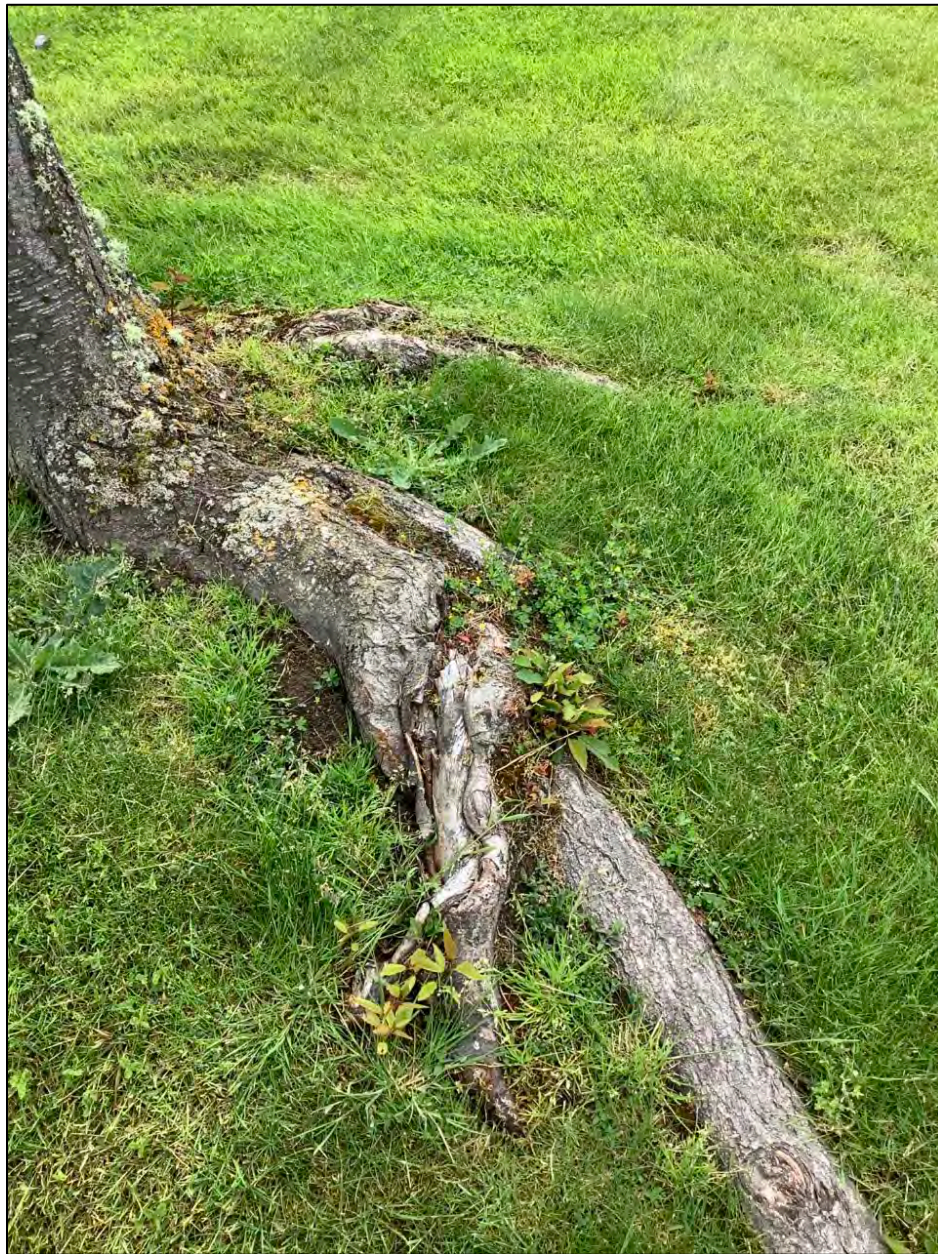
Photo 15: Do not mow or weed whack over roots in grass (Tree 57).

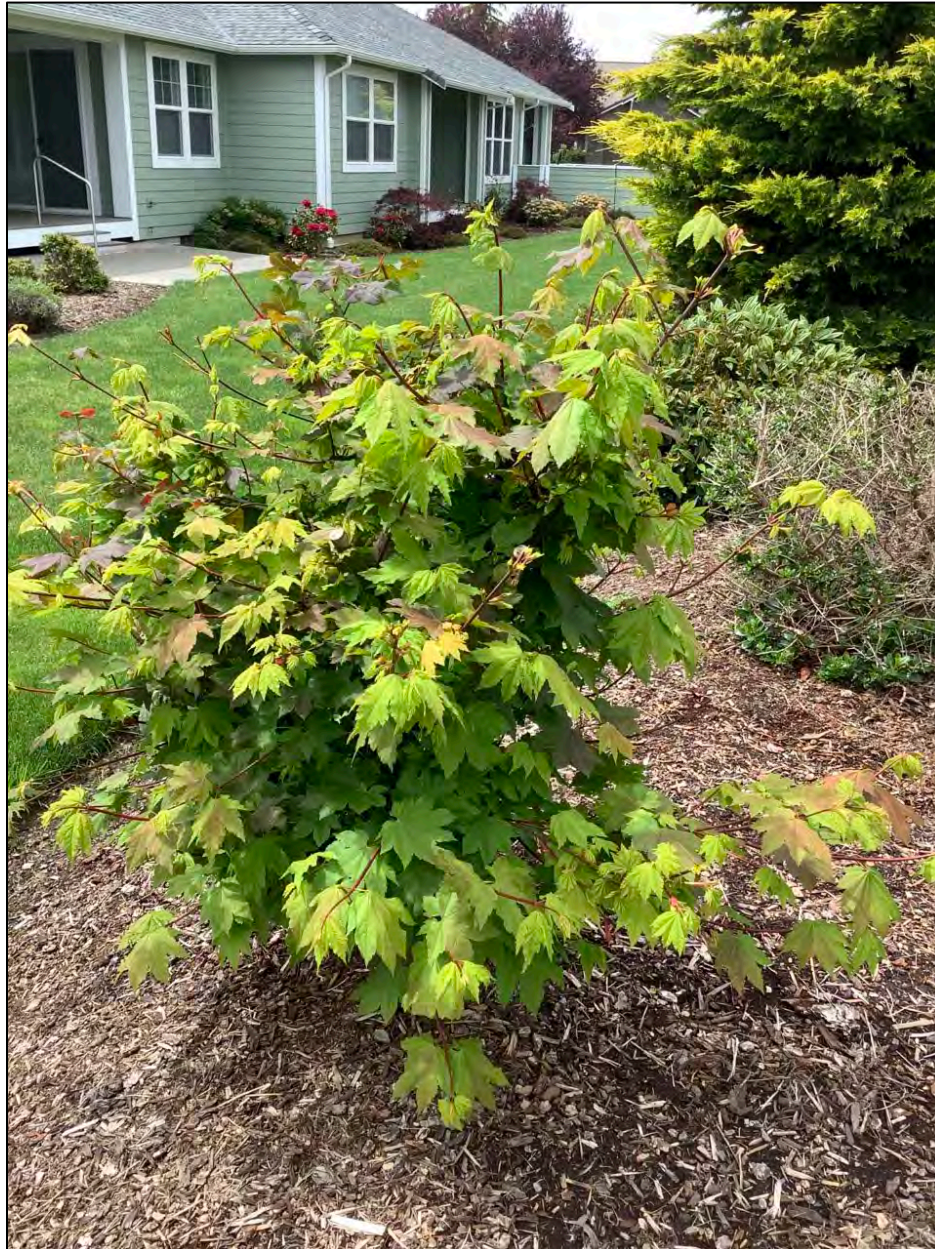
Photo 16: Continue to retop/perform modified coppicing pruning to previously topped trees (this is in corridor with Tree 80).

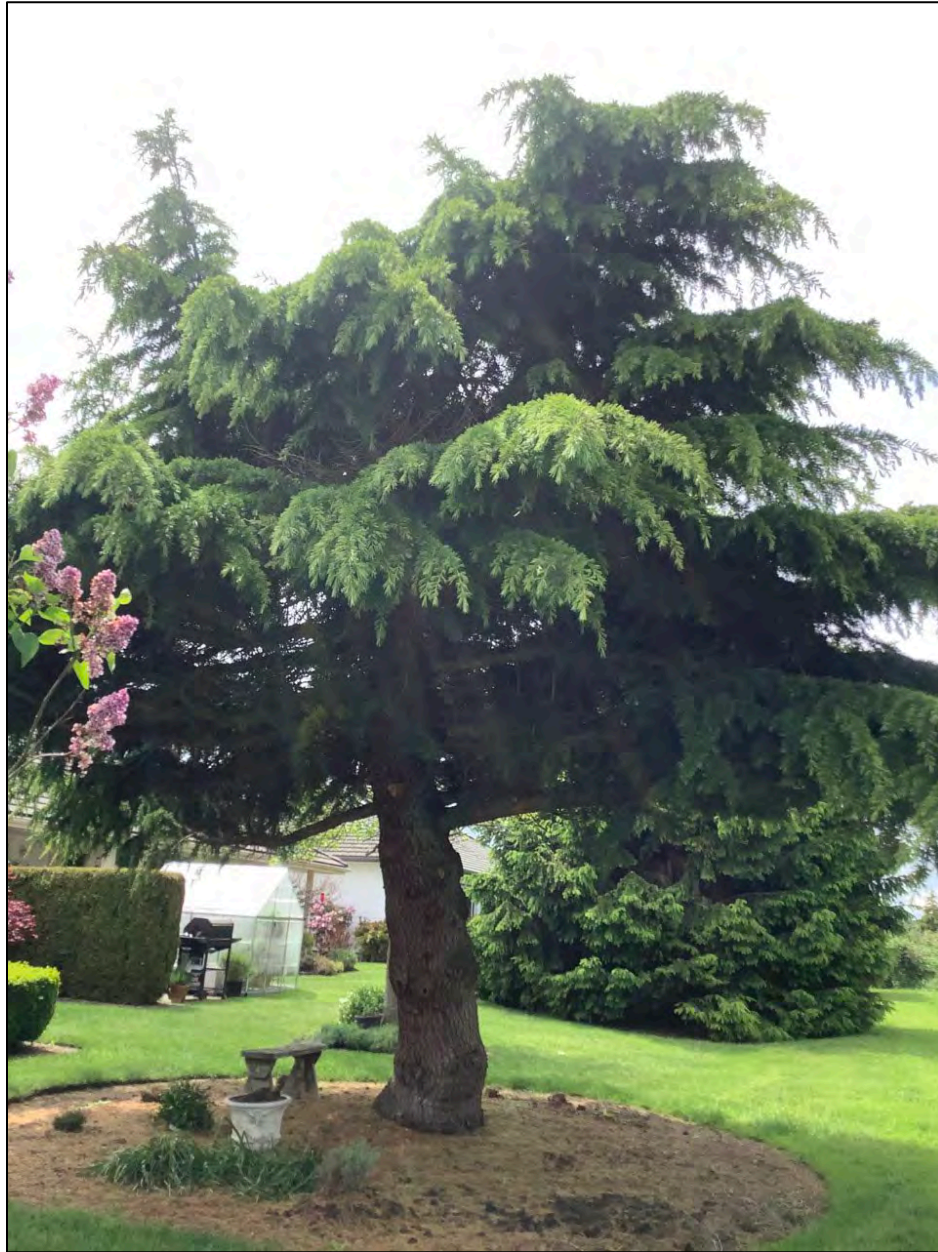
Photo 17: Continue to retop previously topped trees.
