Update "With-Site-Visit" Reserve Study

Sunland Division 17 Owners' Association Sequim, WA

Report #: 19544-6
For Period Beginning: January 1, 2018
Expires: December 31, 2018

Date Prepared: June 30, 2017

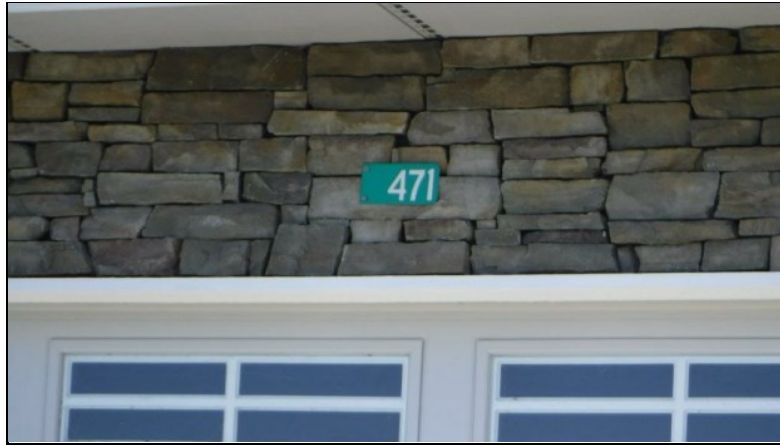
Comp #: 516 Siding: Stone/Brick Veneer - Repair

Evaluation: Some stone and brick veneer was used for cladding on small portions of the garages. No obvious or widespread cracked grout or broken stone/bricks observed during our limited visual review. Stone veneer is a relatively low maintenance item. Inspect periodically and repair as needed using operation and maintenance funds. No predictable basis for reserve funding.

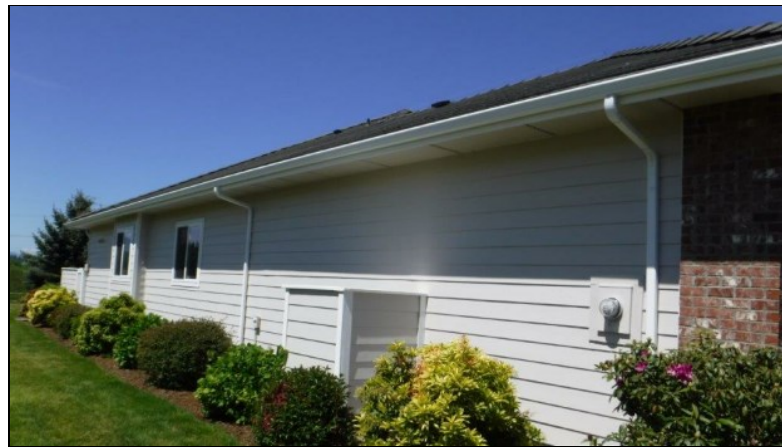
Comp #: 518 Fiber Cement Siding- Replace 1 of 7

History: Local repairs of trim/wood areas

Evaluation: No major damage/deterioration observed of fiber-cement siding including lap, shingle and board/bat orientation.

Fascia and trim appear to be wood. We observed metal head flashing above windows and/or above trim. Our contacts report, some rot/deterioration of trim areas in the past with repairs (and repainting) funded out of the operating budget as needed with routine inspections reported. Actual manufacturer of siding was not confirmed. No view of the critical underlying waterproofing was available as part of our limited visual review.

Replacement will ultimately be needed due to the failure of the underlying waterproofing degrading over the decades, and/or the end of the useful life of the siding materials from general aging. Many factors influence the useful life, including exposure to (or protection from) wind driven rain, and the quality of the waterproofing and flashing beneath the siding. Evaluate the siding and the critical underlying waterproofing (typically building paper or house-wrap) more frequently as the remaining useful life approaches zero years. Adjust remaining useful life as dictated by the evaluation. Align with window replacement for cost efficiencies and building envelope integrity when practical. Inspect annually and repair locally as needed using general maintenance funds.

Project costs can vary depending upon materials chosen and the condition of the underlying structural framing when exposed. We recommend the Board conduct research well in advance in order to define scope, timing and costs, including plan for some margin of contingency.

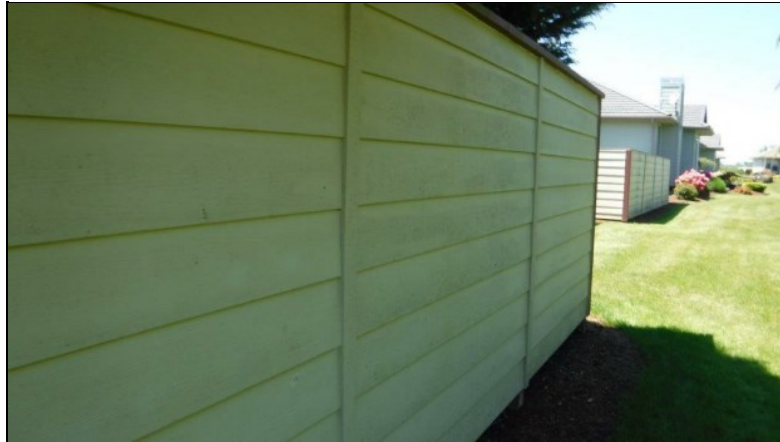
Comp #: 519 Fiber Cement Siding- Replace 2 of 7

History: Local repairs of trim/wood areas

Evaluation: This component is one of several phased siding replacement components. Siding replacement components in this reserve study are aligned with various paint components in this study. This component is for the buildings last repainted in 2016 under component #526. The useful life here of 56 aligns with future recommended 14 year paint cycles. The majority of buildings identified in this component were constructed around 2004. The costs shown here are estimates provided to us by client that were obtained from builder in the community. For complete details on siding, see component #518.

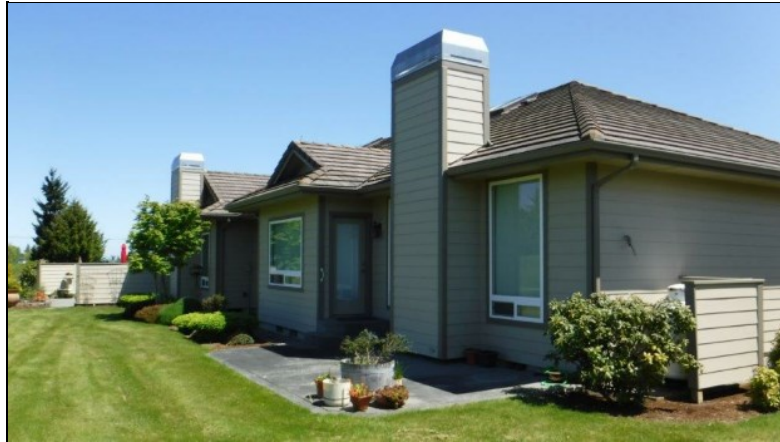
Comp #: 520 Fiber Cement Siding- Replace 3 of 7

History: Local repairs of trim/wood areas

Evaluation: This component is one of several phased siding replacement components. Siding replacement components in this reserve study are aligned with various paint components in this study. This component is for the buildings last repainted in 2015 under component #527. The useful life here of 56 aligns with future recommended 14 year paint cycles. The buildings identified in this component were constructed around 2001-2003. The costs shown here are estimates provided to us by client that were obtained from builder in the community. For complete details on siding, see component #519.

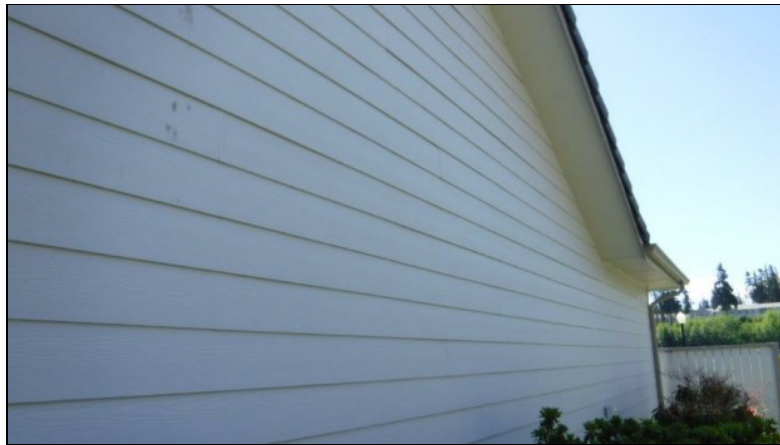
Comp #: 521 Fiber Cement Siding- Replace 4 of 7

History: Local repairs of trim/wood areas

Evaluation: This component is one of several phased siding replacement components. Siding replacement components in this reserve study are aligned with various paint components in this study. This component is for the buildings last repainted in 2014 under component #528. The useful life here of 56 aligns with future recommended 14 year paint cycles. The buildings identified in this component were constructed around 1999-2003. The costs shown here are estimates provided to us by client that were obtained from builder in the community. For complete details on siding, see component #519.

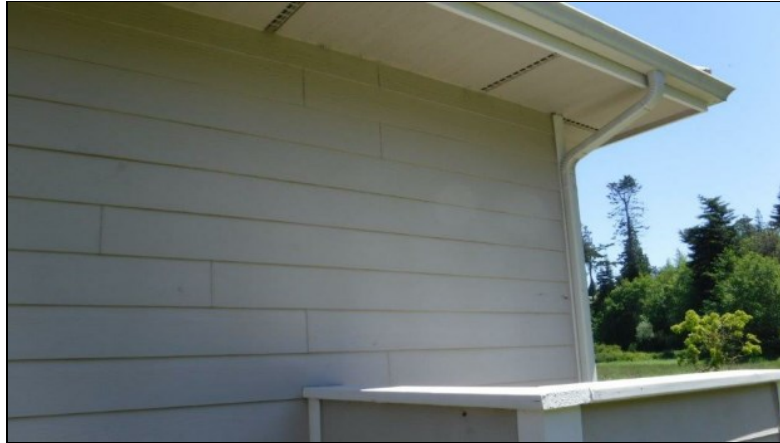
Comp #: 522 Fiber Cement Siding- Replace 5 of 7

History: Local repairs of trim/wood areas

Evaluation: This component is one of several phased siding replacement components. Siding replacement components in this reserve study are aligned with various paint components in this study. This component is for the buildings recommended for painting in 2018 under component #529. The useful life here of 56 aligns with future recommended 14 year paint cycles. The majority of buildings identified in this component were constructed around 2004-2007. The costs shown here are estimates provided to us by client that were obtained from builder in the community. For complete details on siding, see component #519.

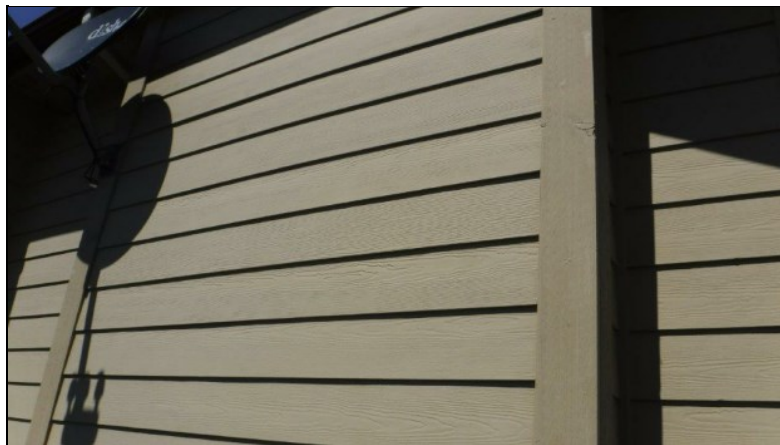
Comp #: 523 Fiber Cement Siding- Replace 6 of 7

History: Local repairs of trim/wood areas

Evaluation: This component is one of several phased siding replacement components. Siding replacement components in this reserve study are aligned with various paint components in this study. This component is for the buildings recommended for painting in 2022 under component #530. The useful life here of 56 aligns with future recommended 14 year paint cycles. The majority of buildings identified in this component were constructed around 2008-2011. The costs shown here are estimates provided to us by client that were obtained from builder in the community. For complete details on siding, see component #519.

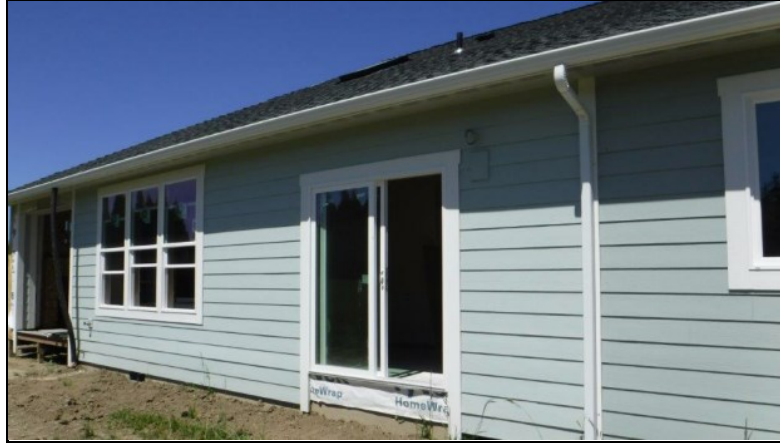
Comp #: 524 Fiber Cement Siding- Replace 7 of 7

History: Local repairs of trim/wood areas

Evaluation: This component is one of several phased siding replacement components. Siding replacement components in this reserve study are aligned with various paint components in this study. This component is for the buildings recommended for painting in 2028 under component #531. The useful life here of 56 aligns with future recommended 14 year paint cycles. The majority of buildings identified in this component were constructed around in 2014 and 2016-2017. The costs shown here are estimates provided to us by client that were obtained from builder in the community. For complete details on siding, see component #519.
