## **“Full” Reserve Study**

## **Sunland Division 17 Owners Association Sequim, WA**

**Report #: 19544-3**  
**For Period Beginning: January 1, 2015**  
**Expires: December 31, 2015**

**Date Prepared: June 19, 2014**

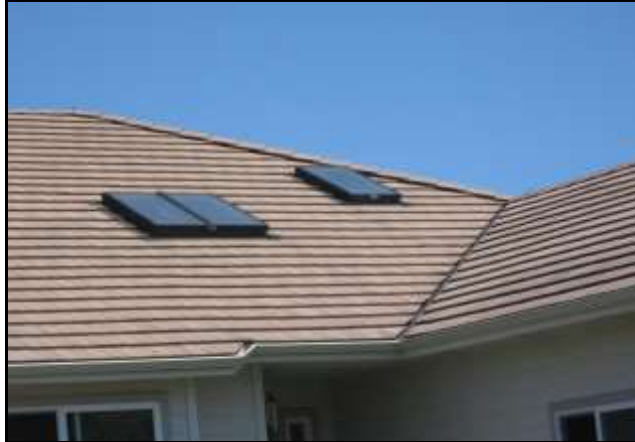
Lower allowance, including skylight and solar tube replacement

Higher allowance, including skylight and solar tube replacement

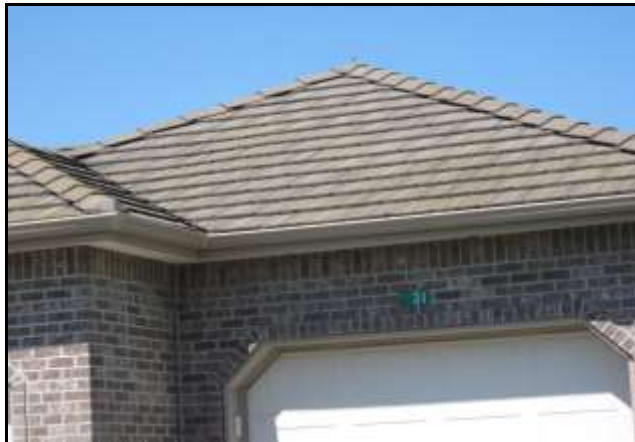
**Comp # : 502 Tile Roofs, Skylights - Replace Ph5** Quantity: (9) buildings  
Location : Roof exteriors - Inc Skylights  
Funded? : Yes

History : No major repairs reported

Lower allowance, including skylight and solar tube replacement

Higher allowance, including skylight and solar tube replacement

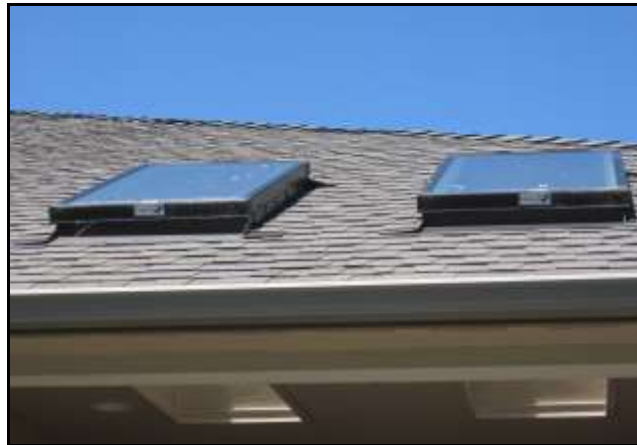
**Comp # : 508 Skylights - Repair/Replace**

History : No reported history of repairs

Evaluation : Close observation of skylights was limited to viewing from ground. Typical skylight warranty for the glass seal is 20 years. Skylight replacement is included in the roof component #502. Review skylight condition with consultant while evaluating the roofing project. Inspect surrounding area routinely for signs of any surrounding leakage. Inspect skylights more closely during roof inspection and repair as needed to maintain waterproof integrity. It was reported to us that skylight replacement is part of common area expenses.

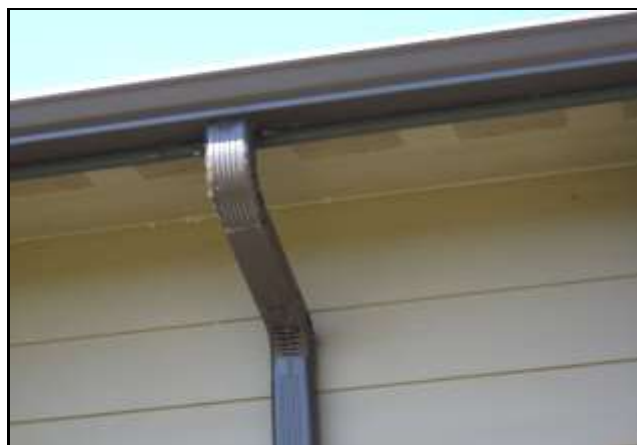
**Comp # : 510 Gutters/Downspouts - Repair/Replace**

History : No reported history of repair

Evaluation : Generally the metal gutters and downspouts appeared in good condition. We suggest planning for total replacement of gutter and downspouts at the same intervals as roof replacement for cost efficiency. National Roofing Contractor Association (NRCA) roofing standard includes installing eave flashings at the gutters. As routine maintenance, inspect regularly, keep gutters and downspouts free of debris.

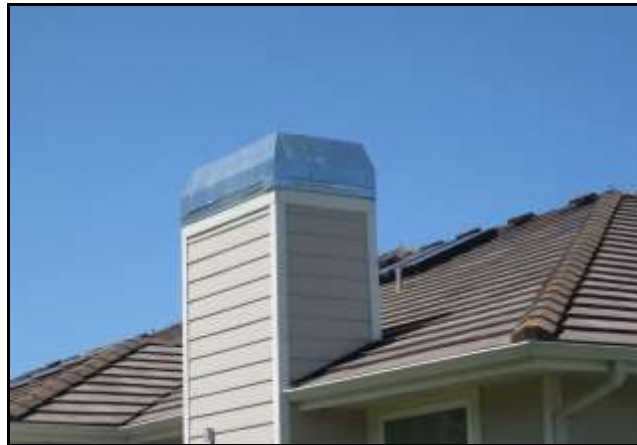
**Comp # : 515 Chimney Covers and Flues - Replace** Quantity: (52) buildings

Evaluation : Observation of top of chimney was limited to viewing ground. Metal chimney covers appeared in fair condition. We typically include replacement cycle timed to coincide with re-roofing. Review condition of chimney caps and flue caps with consultant while evaluating the roofing project. As routine maintenance, inspect and clean during roof maintenance. Repair locally as needed. Assuming proactive maintenance, plan for total replacement at roughly the time frame indicated below.

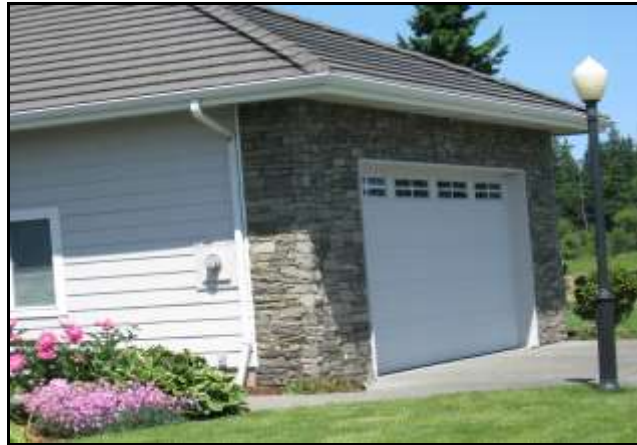
Comp # : 525      Siding: Stone Veneer - Repair      Quantity: ~(26) buildings

Evaluation : Some stone veneer was used for cladding on small portions of the garages. No cracked grout or broken stone were observed during our limited visual review. Stone veneer is a relatively low maintenance item. Inspect periodically and repair as needed using operation and maintenance funds. No reserve funding suggested.

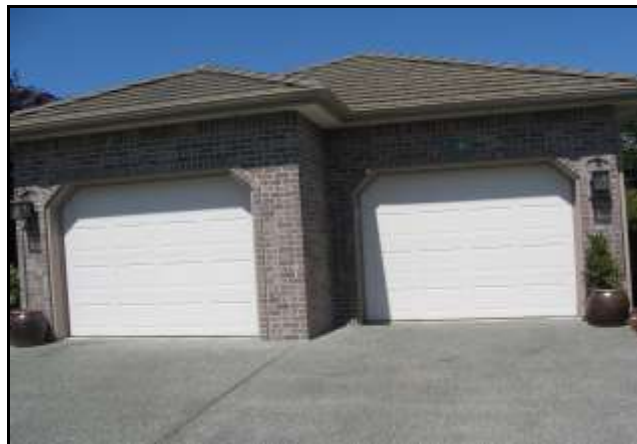
Evaluation : Minimal spalling of brick or cracking of mortar was noted during our limited visual review. Condominium reported. No basis for reserve funding at this time. Brick is typically a low maintenance material that usually requires little maintenance work. After 50-years or so, mortar between brick can require repointing. Repointing involves grinding out small sections of existing mortar and installing new mortar and continuing on until all the mortar has been replaced. As the brick and mortar ages cracking may appear, indicating need for repointing. Currently there is no predictable scope or timing for repointing work. Reserve study review is for financial planning purposes only, and if a thorough investigation of brick and mortar is desired, we recommend having a masonry specialist inspect the brick and mortar. Funding can be added to future updates to the reserve study if scope and timing become known.

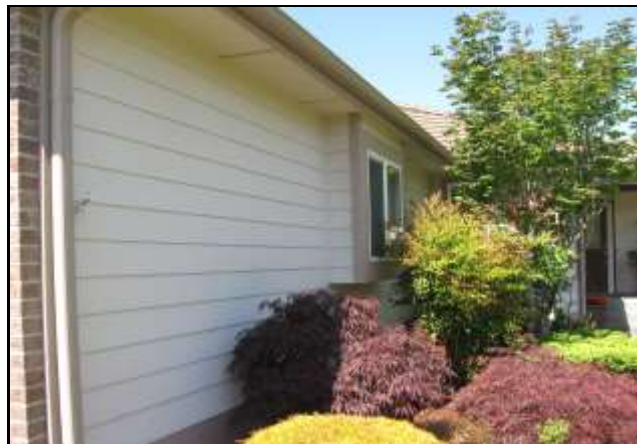
Evaluation : The painted surface of the wood trim and the siding appeared in fair good condition with no noticeable peeling or blistering of the painted observed. Siding types included horizontal siding. Siding material appears to be fiber cement. Useful life below is based on the associations history. Evaluate and adjust remaining useful life as it approaches zero years. As routine maintenance, inspect regularly (including sealants) repair locally and touch-up paint as needed. Typical Northwest paint cycles vary greatly depending upon many factors including; type of material painted, surface preparations, quality of primer/paint/stain, application methods, weather conditions during application, moisture beneath paint, and exposure to weather conditions. Proper sealant/caulking is critical to keeping water out of the walls, and preventing water damage. Two common types of sealants/caulking are urethane and silicone. If properly installed, urethane has a life of approximately 6-9 years and silicone's life can be 16-20 years. Incorrect installations of sealant are common, and can greatly decrease its useful life. Inspect sealant, more frequently as it ages, to determine if it is failing. Typical sealant problems include failure of sealant to adhere to adjacent materials and tearing/splitting of the sealant itself. As sealants age and are exposure to ultra-violet sunlight, they will dry out, harden, and lose their elastic ability. Remove and replace sealant as signs of failure begin to appear. Proper cleaning, prep work, and proper installation are critical for a long lasting sealant/caulking. Do not install sealant in locations that would block water drainage from behind the siding. Repair areas as needed prior to painting/caulking. Additional information on painting is available through American Coatings Association at <http://www.paint.org/>

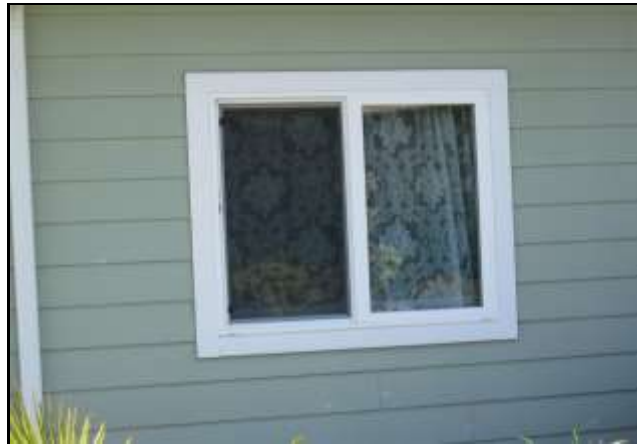
Comp # : 535      **Windows, Sliders - Repair/Replace**      Quantity: (52) buildings

History : No reported history of repair/replacement

Evaluation : Windows appear to be vinyl frames. Weep holes, at exterior lower corners, were observed to be clear, in the few windows sampled for our report. No condensation was observed between window panes, which is typically indicative of failed glazing seals. Factors effecting useful life include: quality of windows and installation, waterproofing flashing details, exposure to wind driven rain, building movement over time, structural details, etc... We recommend financially planning for a 30-year useful life range timed with other large scale building exterior projects for efficiency and proper integration into waterproofing systems. Note: there are many types of glazing and windows types, material and quality, available in today's market; and costs can vary greatly. Inspect regularly, including sealant, and repair as needed. Keep weep holes free and clear to allow proper drainage of water that gets into window frame. Do not block (caulk or seal) gap at top of head flashing, as this allows water that gets behind the siding to drain out. Proper sealant/caulking is critical to keeping water out of the walls, and preventing water damage. Two common types of sealants/caulking are urethane and silicone. If properly installed, urethane has a life of approximately 6-8 years and silicone's life can be 16-20 years. Incorrect installation of sealant is common, and can greatly decrease its useful life. Inspect sealant, more frequently as it ages, to determine if it is failing. Typical sealant failures include; lack of adherence to adjacent materials, tearing/splitting of the sealant itself, and lose of elastic ability. Lose of elastic ability can be caused by exposure to ultra-violet light and general aging. Remove and replace all sealants as signs of failure begin to appear. Proper cleaning, prep work, and proper installation are critical for a long lasting sealant/caulking. It has been reported to us that window replacements are the individual unit owners responsibility.
