Sunland North HOA
Contact: Shirley Legg
320 Blakely Blvd | Sequim, WA 98382
206-550-5604 | vicepresident@sunlandnorth.org
Clallam County Parcels: 033008760006 and 033008760002

Sunland North Homeowner's Association (Sunland North HOA) owns the trees on Clallam County Parcel numbers 033008760006 and 033008760002 in Sequim. Sunland North HOA asked Peninsula Environmental Group to perform a tree risk assessment on trees bordering property target zones and to prepare a map and a report with detailed findings.

320 Blakely Blvd | Sequim, WA 98382

Tree Risk Assessment

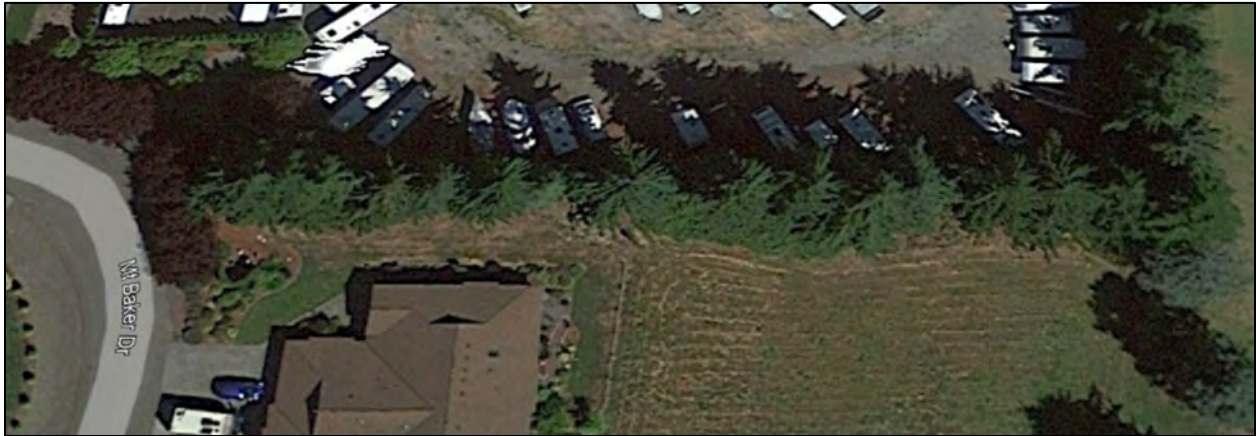
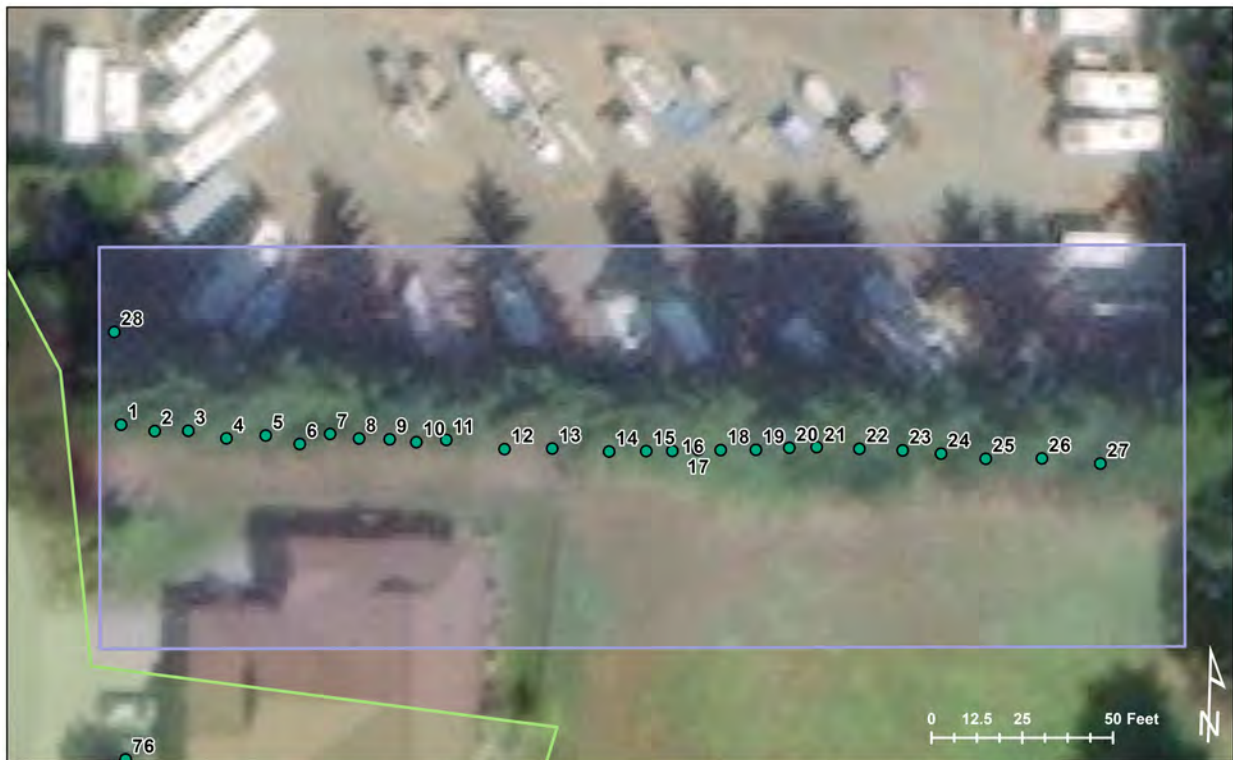
Figure 2 and Figure 3: Close up of Zone 1 map of trees and numbered trees.

Tree #	Common Name	Scientific Name	Risk Rating	Notes and Recommendations
1	Douglas-fir	<i>Pseudotsuga menziesii</i>	Low	Some dead branches below. Remove dead branches.
2	Douglas-fir	<i>Pseudotsuga menziesii</i>	Low	Some dead branches. Remove dead branches. Note broken lamp fixture next to branch.
3	Douglas-fir	<i>Pseudotsuga menziesii</i>	Low to moderate	Multiple leaders at about 5 feet from ground, though there is one dominant leader . Remove dead and further reduce secondary leaders. Remove dead wood at base.
4	Western redcedar	<i>Thuja plicata</i>	Moderate	Two tops intertwined together starting around 15 to 20 feet. Included bark. Targets are RV park and house. Consider removal.
5	Western redcedar	<i>Thuja plicata</i>	Low	Young. Multi-stemmed. Consider removal. Low risk currently but will likely grow into higher risk- there is included bark and the weak attachment will likely continue to grow.

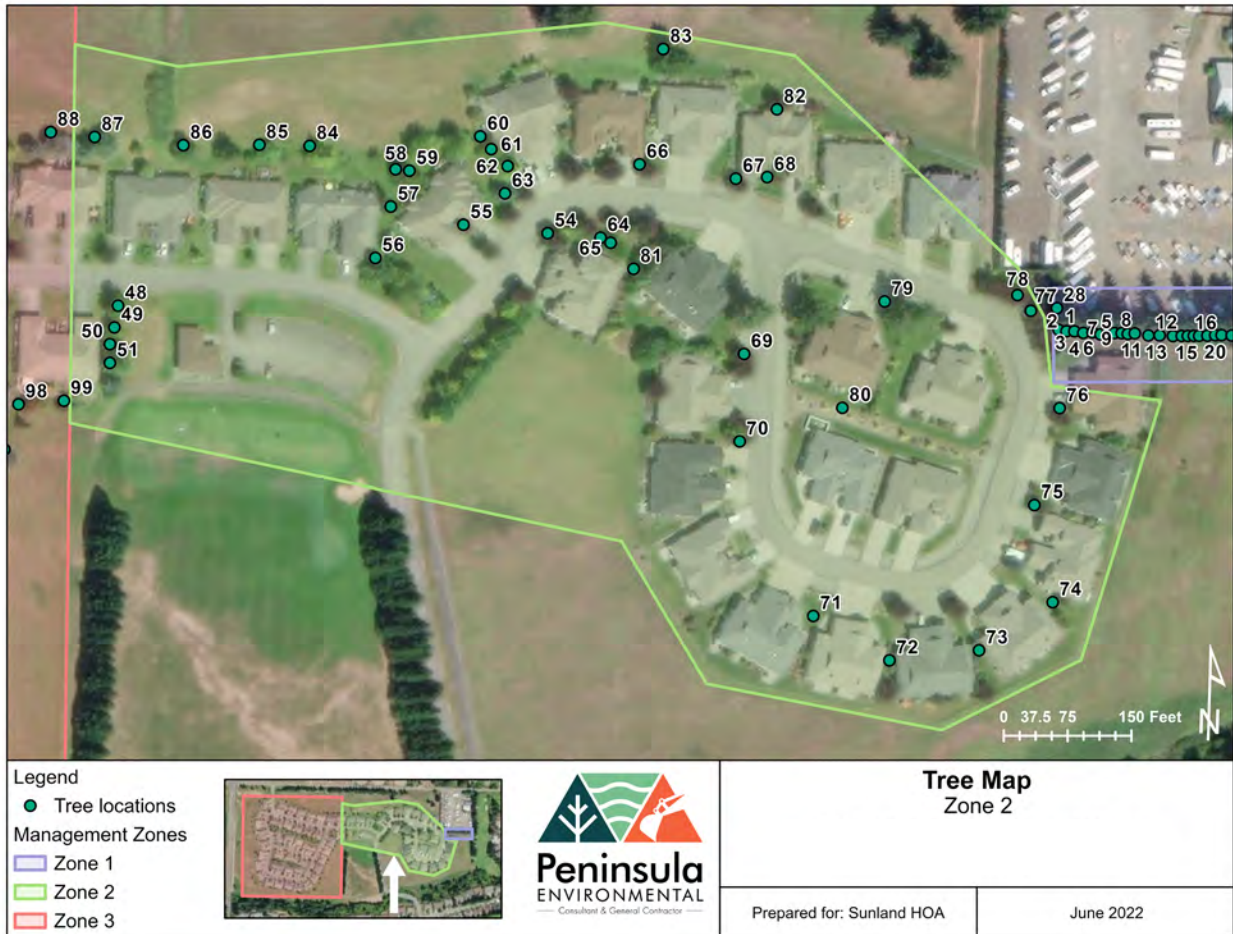
Figure 4: Zone 2 labeled in green.

Tree #	Common Name	Scientific Name	Risk Rating	Notes and Recommendations
48	Cherry	<i>Prunus</i> sp.	Low	Irrigation is too close the trunk and being strangled by roots. Replace or move irrigation further from trunk.
49	Cherry	<i>Prunus</i> sp.	Low	Prune branches away from roof.
50	Shore pine	<i>Pinus contora</i> 'Contorta'	Low	Prune rubbing and crossing branches. Reduce competing leaders. There are the two biggest that are very close to each other. Reduce one. Prune branches away from roof.
51	Pine	<i>Pinus</i> sp.	Low	Prune branches away from roof.
54	Purple leaf plum	<i>Prunus cerasifera</i>	Low	Prune branches away from house.
55	Japanese maple	<i>Acer palmatum</i>	Low	Touching sides of house and roof. Prune back and consider replacing with more suitable option.
56	Deodar cedar	<i>Cedrus deodara</i>	Moderate	Consider higher level Tree Risk Assessment and using micro resistance drill . Wound at base about 1 to 2-feet wide and 3-feet high.

57	Weeping Nootka cypress	<i>Chamaecyparis nootkatensis</i> 'Pendula'	Moderate	Three trunks with included bark at base. One of them splits into two more trunks close together. The way they are most likely to fail will be into the grass, but the tree is located close to two houses. Consider cabling or remove and replace with smaller tree.
58	Norway spruce	<i>Picea abies</i>	Low	Appears healthy and low-risk but there is large amounts of sap running down the trunk. There is sapsucker (<i>Sphyrapicus</i> sp.) presence and damage, which is usually relatively benign. Continue to monitor tree.

59	Nootka cypress	<i>Cupresses nootkatensis</i>	Low	Growing very close to Norway spruce but appears to straighten out at the end, displaying phototropism .
60	Norway maple	<i>Acer platanoides</i>	Low	Very dense. Thin for health.
61	Red maple	<i>Acer rubrum</i>	Low	Prune branches away from roof.
62	Deodar cedar	<i>Cedrus deodara</i>	Low	Prune branches away from roof. Trunk is over buried . Unbury trunk.
63	Blue spruce	<i>Picea pungens</i>	Low	Roots are starting to get damaged from lawnmower. Do not mow over roots.
64	Deodar cedar	<i>Cedrus deodara</i>	Low	Prune branches away from roof.
65	Japanese cherry	<i>Prunus serrulata</i>	Low	Prune branches away from roof.
66	Purple leaf plum	<i>Prunus cerasifera</i>	Low	Planted too close the driveway. Low-risk but consider planting more appropriately sized tree.
67	Purple leaf plum	<i>Prunus cerasifera</i>	Low	Prune branches away from roof.
68	Japanese maple	<i>Prunus cerasifera</i>	Low	Prune branches away from roof.

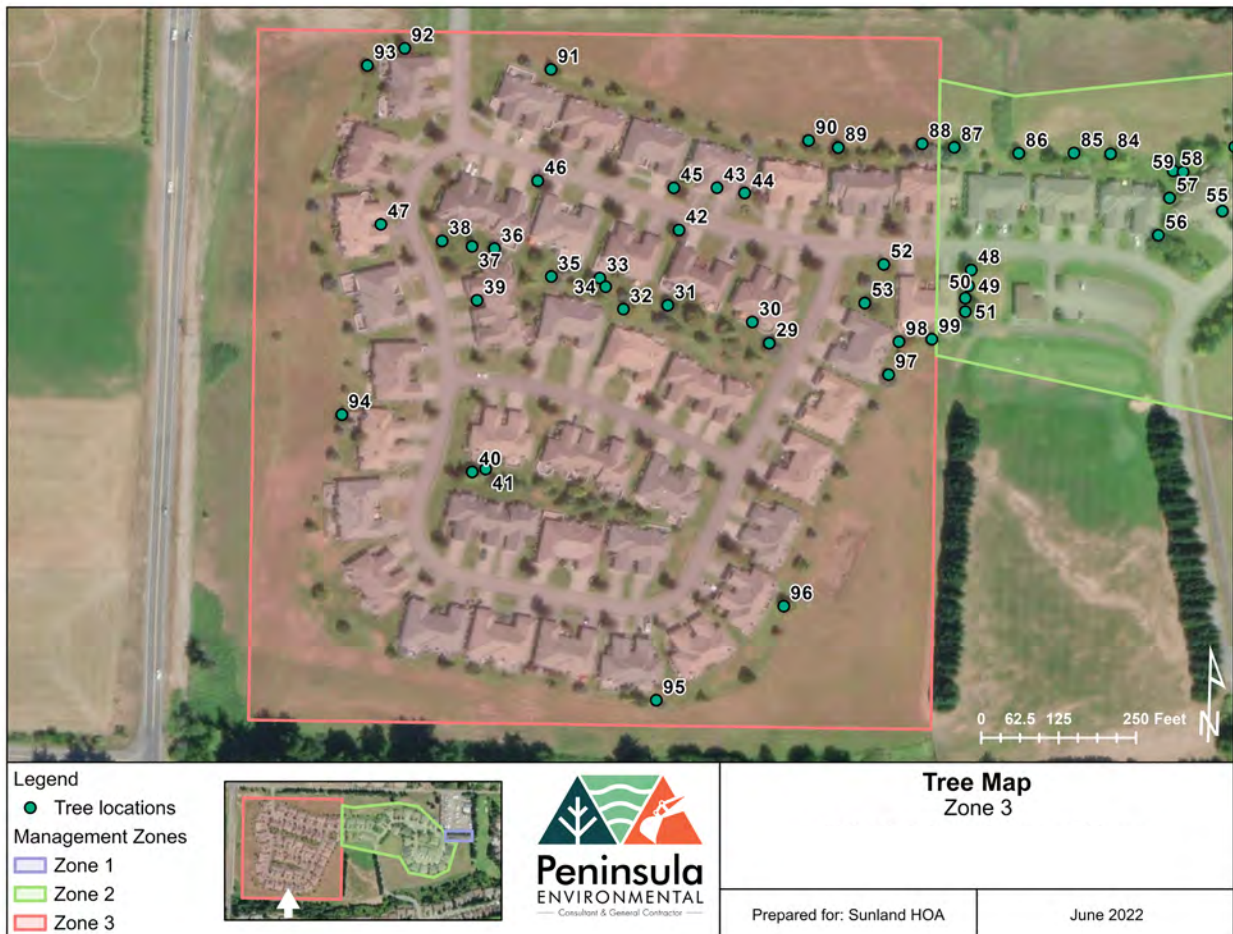
Figure 5: Zone 3 labeled in red.

Tree #	Common Name	Scientific Name	Risk rating	Notes and Recommendations
29	Blue spruce	<i>Picea pungens</i>	Low	Low-risk now but reduce competing leaders.
30	Cherry tree	<i>Prunus sp.</i>	Low	Low-risk but multiple dead branches near fence. Could possibly break off on roof with minimal damage. Remove dead branches. Consider replacing with more appropriate tree.
31	Spruce	<i>Picea sp.</i>	Low	Continue to monitor for structure.
32	Juniper	<i>Juniperus sp.</i>	Low	Fix old wounds to proper pruning cuts . Reduce secondary leader for long term structure.
33	Western redcedar	<i>Thuja plicata</i>	Low	Multi stemmed at base. Will be an issue in the future. Consider removal and replace. Trees # 33 and 34 look like one tree from the outside but are two separate trees.
34	Western redcedar	<i>Thuja plicata</i>	Low	This tree is healthy and will benefit from Tree 33 being removed and replaced with a more appropriate tree further away.

45	Japanese maple	<i>Acer palmatum</i>	Low	Prune branches away from roof.
46	Purple leaf plum	<i>Prunus cerasifera</i>	Low	Prune branches away from roof.
47	Maple	<i>Acer sp.</i>	Low	Prune branches away from structures.
52	Purple leaf plum	<i>Prunus cerasifera</i>	Low	Low-risk but be careful of roots in grass. They are being damaged by lawnmower. There is also a machine scar on one of the branches.
53	Japanese cherry	<i>Prunus serrulata</i>	Low	Branches are getting close to roof. Prune branches back. Careful of roots in grass. Watch out for lawnmower damage.
